9.0 EFFECTS OF GROUND FAILURE ON BRIDGES, ROADS, RAILROADS, AND LIFELINE SYSTEMS

9.1 Introduction

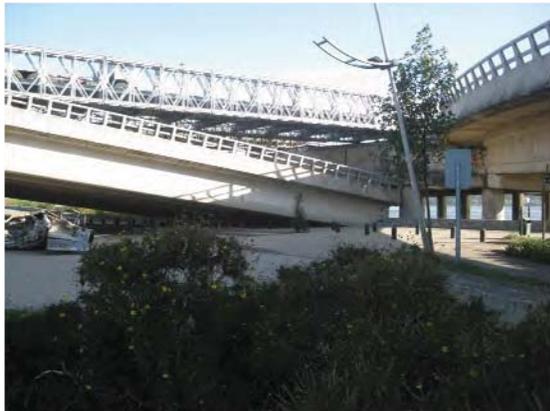
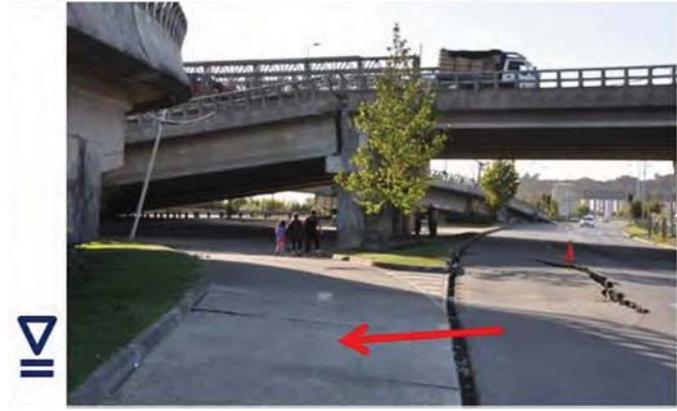
The observed damage at the north approach of the Llacolén Bridge (S36.830108°; W73.067991°) suffered deck unseating and lateral spreading.

Figure 9.5. Deck unseating at Llacolén bridge in Concepción. (note the temporary deck supporting approach traffic). View South ($S36.829707^\circ$, $W73.068220^\circ$, 1809 hrs on 3/14/2010) and (b) view north ($S36.830380^\circ$, $W73.067541^\circ$, 1911 hrs on 3/14/2010).

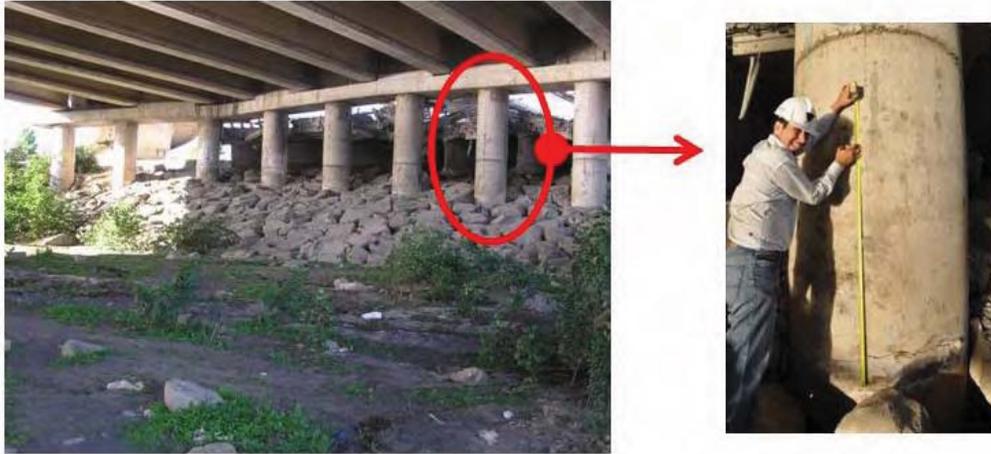
Figure 9.6. Substructure of the of the north approach to the damaged Llacolén bridge in Concepción showing the unseated deck in the foreground. Flexural cracking of the column supports was observed at ground level and extending to the construction joint (2-2.5m above ground) for all columns at this support (S36.830232°, W73.068379°, 1936 hrs. on 3/14/2010).

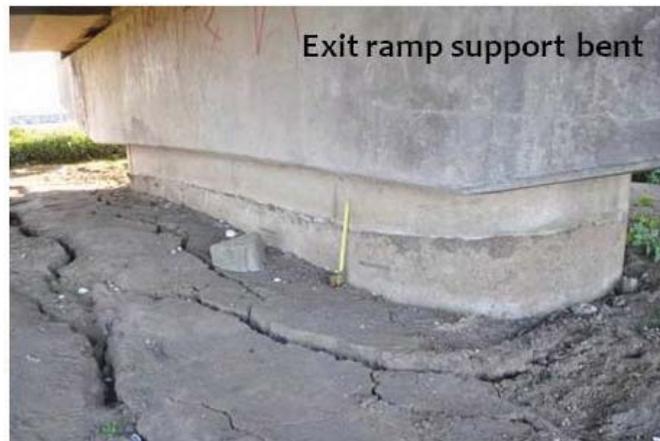
Figure 9.7. Ground settlement surrounding an exit ramp support bent at the Llacolén bridge in Concepción (S36.830380°, W73.067541°, 1901 hrs. on 3/14/2010).

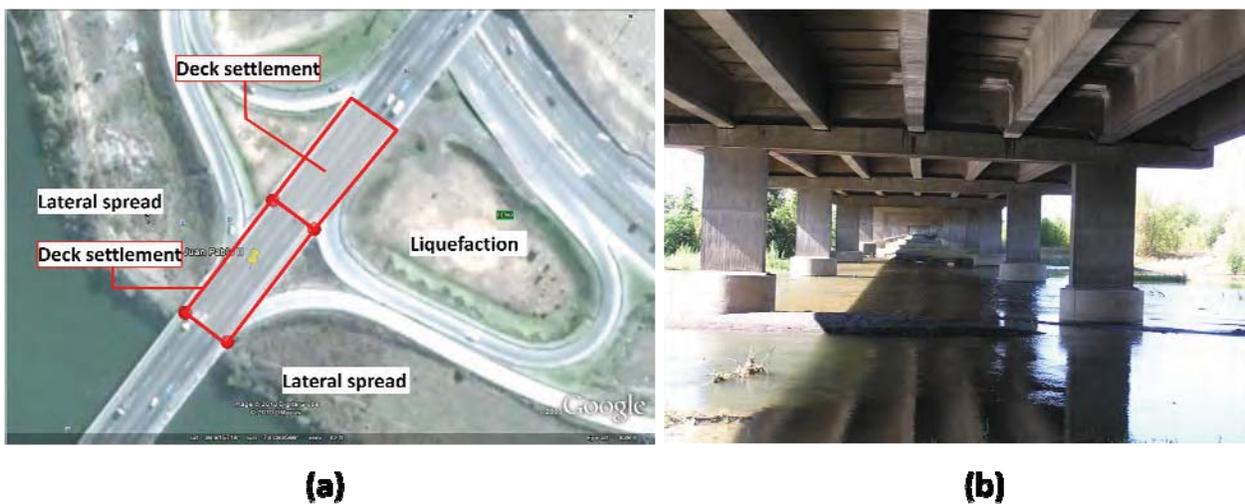
The Juan Pablo II Bridge (S36.815864°; W73.083674°), also known as Puente Nuevo (New Bridge), is the longest vehicular bridge in Chile with a length of 2310 m. The damage observed here was lateral spreading on the North East approach and liquefaction-induced settlements along the bridge (Figure 9.9a).

Figure 9.9. Juan Pablo II Bridge (a) Google Earth view of northeast Approach with schematics of observed damage (S36.815864° W73.083674°) (b) Typical bridge bent configuration (S36.828181° W73.095850°; 1636 hrs on 3/15/2010)

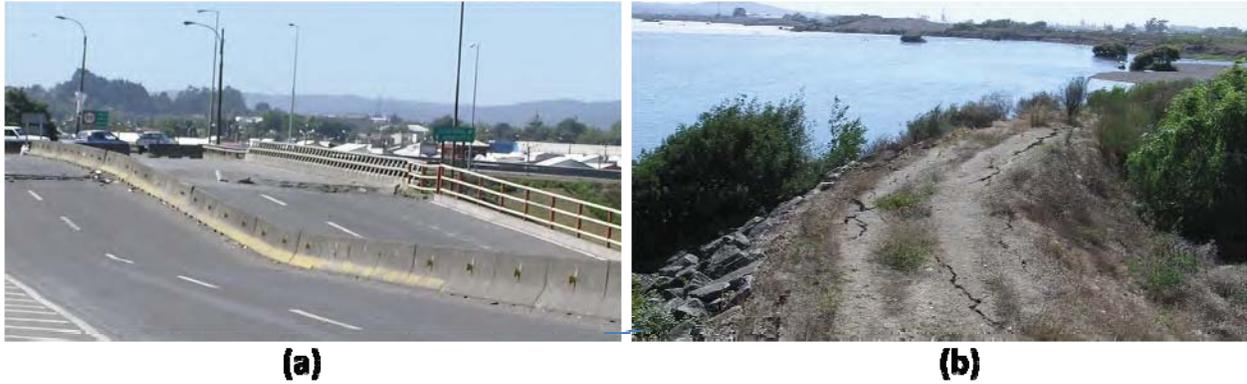
During the 2010 Chile earthquake, the bridge suffered severe damage and was closed to the public. Evidence of liquefaction and lateral spreading was observed in the north-east approach with significant effects on the bridge. A Google Earth view of the northeast approach with schematics of the observed ground failure and structural effects is shown in Figure 9.9b. As shown in Figure 9.10, liquefaction of the soil and lateral spreading in the embankment contributed to settlements and lateral displacement of the bridge deck. Visual inspection of the surrounding soils indicated the presence of fine loose sands. Several sand ejecta features were observed near the structure on the south and north sides of the embankment as shown in Figure 9.12. Several samples of the ejected soil were taken at this site, and grain size analysis and Atterberg limit testing are being performed. The results of this testing will be included in later versions of this report.

Figure 9.10. Juan Pablo II northeast approach: (a) Settlement of bridge deck near bridge approach (S36.815900° W73.084064°; 1455 hrs on 3/15/2010), (b) Lateral spreading on northeast bridge abutment.

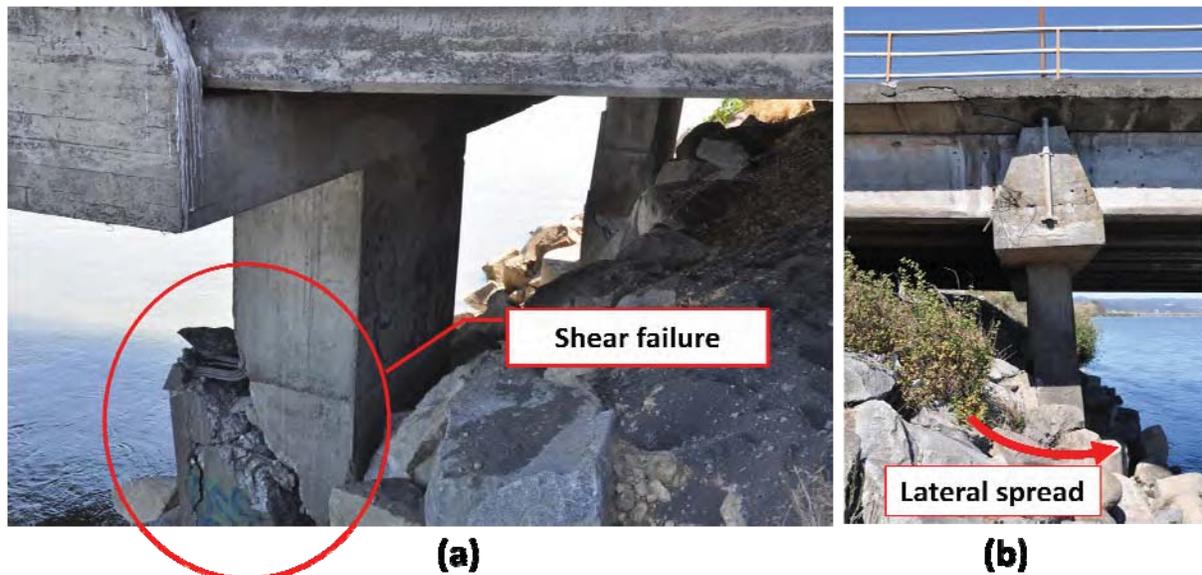
Column shear failure and significant displacements and rotation of the bridge bent were observed on the north-east approach. Figure 9.11(a) shows shear failure of the column facing the bent's south side. The north column, shown in Figure 9.11(b), shows evidence of tension cracks and rotation and also suffered shear failure. In contrast with the damage observed at the northeast approach to the bridge, the southwest approach suffered minor damage.

Figure 9.11. Juan Pablo II northeast approach: (a) Column shear failure (S36.816233° W73.084144°; 1528 hrs on 3/15/2010) (b) Rotation and lateral displacement of bridge bent (S36.816233° W73.084144°; 1530 hrs on 3/15/2010)

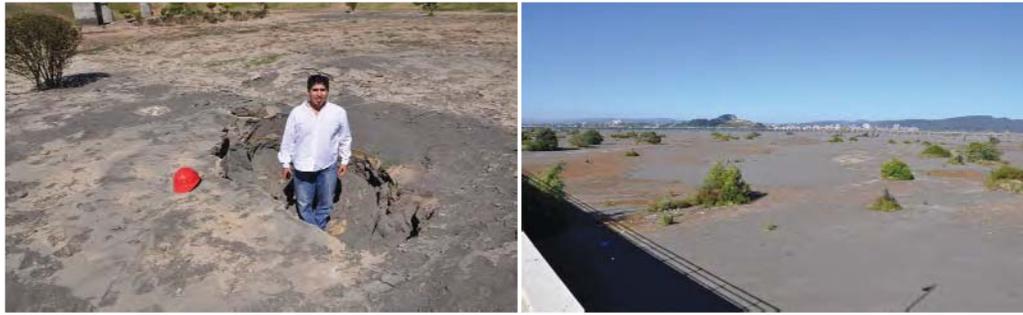
Noticeable pier settlements were observed at several locations along the length of the bridge. Vertical settlements appeared to be due to liquefaction of the soil near the pier foundations. Visual inspection of the surrounding soils indicated the presence of loose sands near the surface. Although the Bio Bio River was once navigable by ship up to the City of Nacimiento, over-logging during the twentieth century has led to heavy erosion that has choked the river with silt and rendered it impossible to ship traffic. Near Concepción the river behaves as a meandering river with fine-grained material deposited on the floodplains. The GEER team identified several sand boils near the approaches (e.g. Figure 9.12a) and along the bridge spans (in sections not covered by water). The presence of fine material is clearly shown in Figure 9.12(b).

Figure 9.12. Juan Pablo II bridge: (a) Sand ejecta near northeast approach and (S36.815619° W73.083311°; 1522 hrs on 3/15/2010) (b) Fine-grained material in the floodplains (S36.825592° 73.093264° on 3/15/2010).

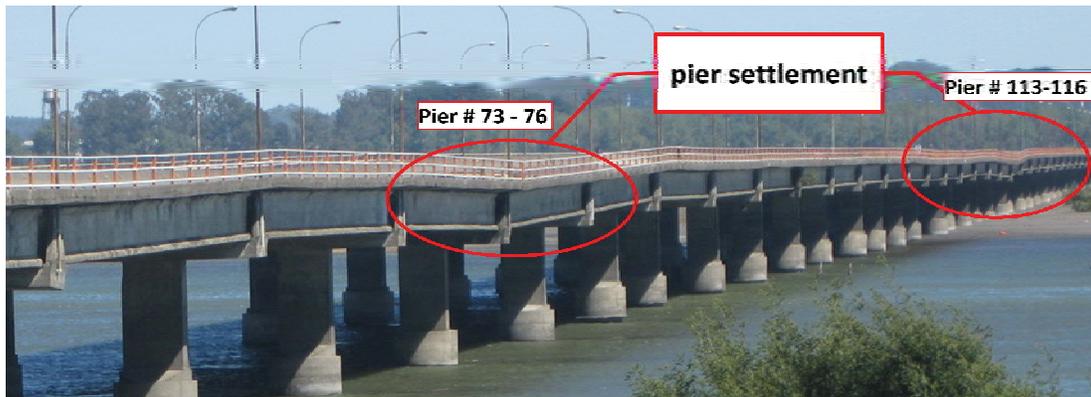
Settlements on the order of 0.50 m to 0.70 m were observed in piers #73-76 and piers #113-116 as indicated in Figure 9.13 (odd numbers for piers on the north side and even numbers for piers on the south side). The bridge deck accommodated these settlements with large vertical deformations but with relatively minor damage of the asphaltic layer. This is observed in Figure 9.14(b). Settlements of piers # 73, 75, 113 and 115 on the south side were larger than those at piers #74, 76, 114, and 116 on the north side indicating rotation of the bridge bents.

Figure 9.13. Juan Pablo II bridge – Pier settlements (S36.815122° W73.084369°; 1453 hrs on 3/15/2010)

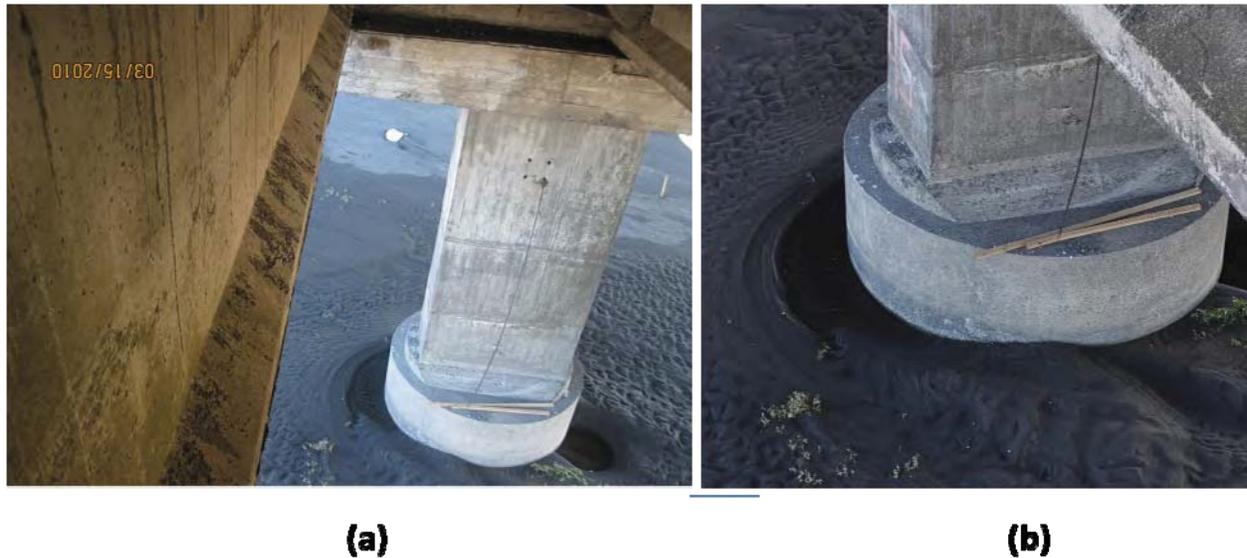
Although the GEER team had no direct access to the piers subjected to liquefaction and settlement it was possible to obtain some photos of the affected foundations. Figure 9.15(a) and (b) show the top view of a pier corresponding to pier group #113-116 and a close-up of the soil-pier interface. The figure shows the effects of liquefaction of the soil surrounding the pier with soil depressions and standing water covering an annular section around the pier. The soil in the vicinity of the pier shows evidence of water being brought to the surface and accumulation of sand probably ejected during the liquefaction event.

Figure 9.15. Juan Pablo II bridge—Evidence of liquefaction at piers subjected to settlements.(a)column and pier, (b) detail of pier and surrounding soil. (S36.826596° W73.094345° on 3/15/2010)

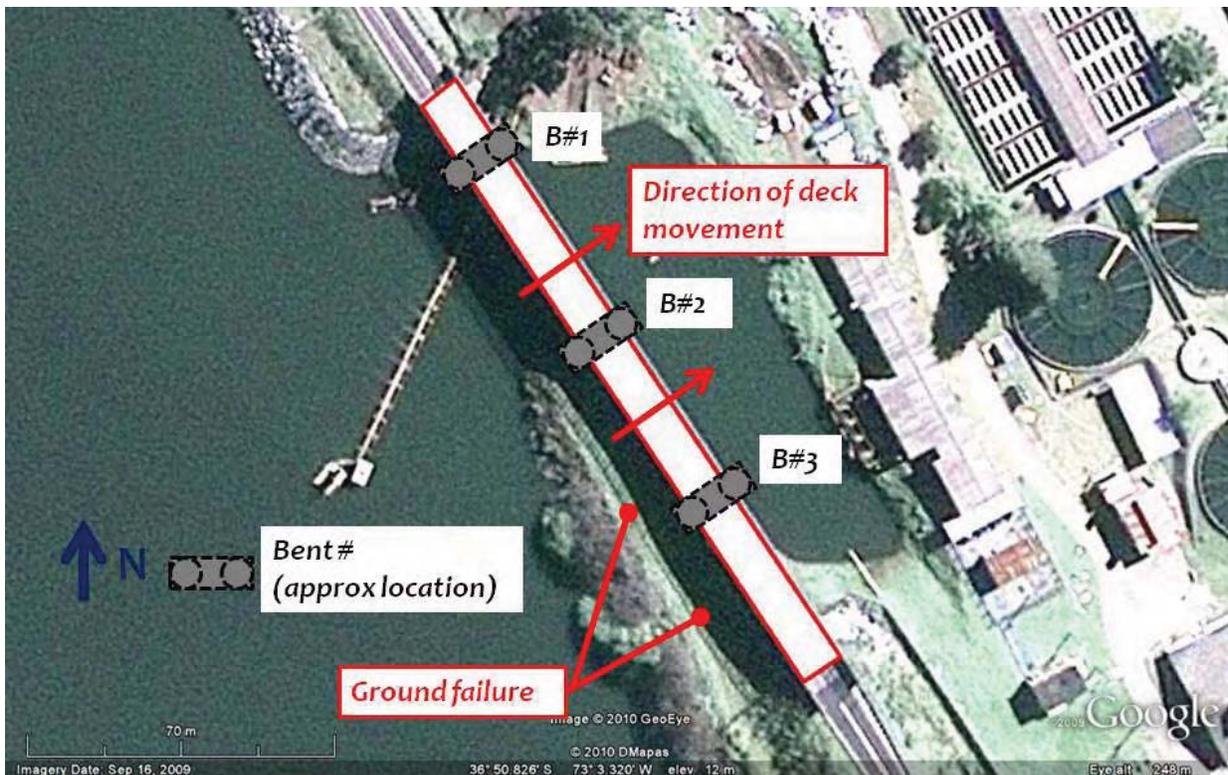
La Mochita bridge, shown in Figure 9.16 (S36.846841°; W73.055496°), is a 4-span concrete bridge supported by seat-type abutments at each end and two-column bents at the interior locations. At this site, ground failure occurred which induced transverse movement of the bridge superstructure.

Figure 9.16. Plan view of the La Mochita bridge in south Concepción describing observed damage (S36.846841° W73.055496°).

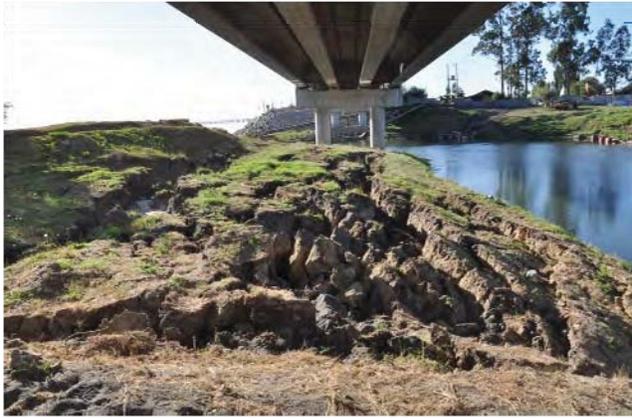
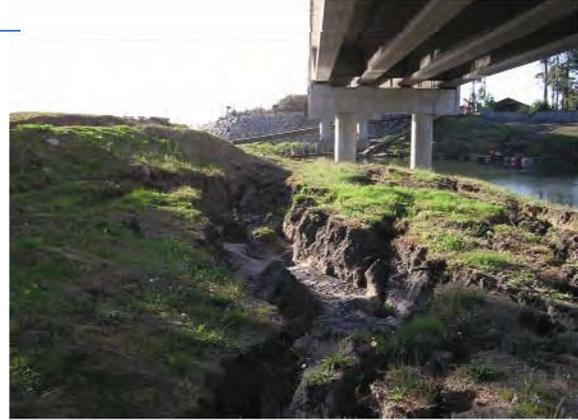
The bridge superstructure shifted transversely largely as a unit towards the east due to failure of the soil mass surrounding bents 2 and 3. Upon inspection of the ground at bents 2 and 3, significant spreading-like failure towards the water treatment plant inlet water was observed (Figure 9.17). This failure may have been attribute to either a deep seated slope instability or liquefaction-induced lateral spreading mechanism. It is noted that sand boils below the bridge were observed near bent #2 and 3 (Figure 9.18). Follow-up site investigation is being conducted by GEER to more fully understand the characteristics of

Figure 9.17. Ground failure at the La Mochita bridge, (a) looking north at bent #3 (S36.847389°, W73.055219°; 1831 hrs on 3/15/2010) and (b) looking north at bent #2 (S36.847495°, W73.055027°; 1835 hrs on 3/15/2010)

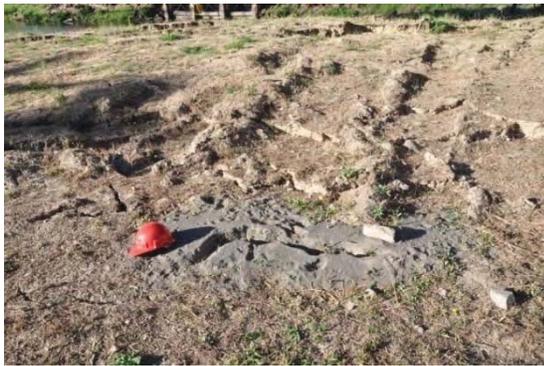
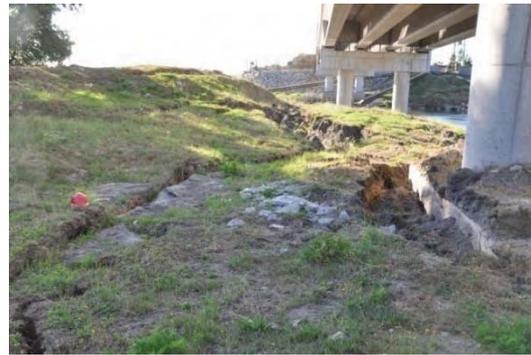
Figure 9.18. La Mochita bridge: (a) Sand boils observed below the bridge (S36.847456°, W73.055129°; 1830 hrs on 3/15/2010), and (b) View looking north (S36.847453° W73.055225°; 1830 hrs on 3/15/2010)

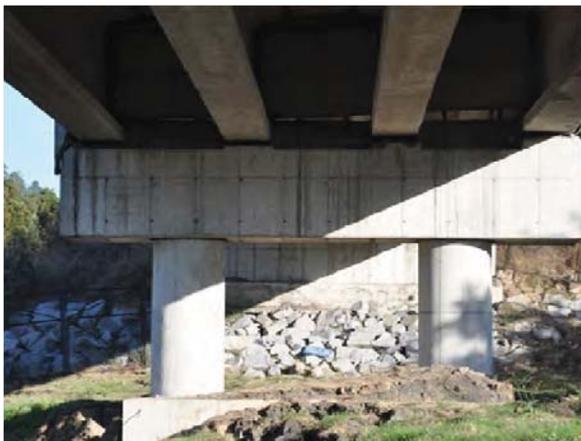
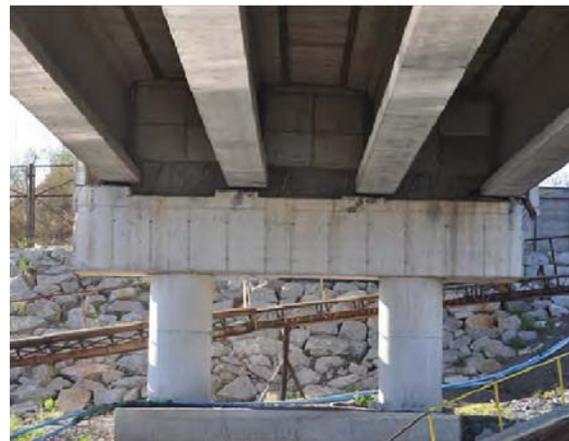
Figure 9.19. La Mochita bridge: (a) Rotation of bent #3 and surrounding ground failure at La Mochita bridge. View looking south (S36.847302°, W73.055151°; 1835hrs on 3/15/2010), and (b) Transverse shift of deck relative to bent #1. (the tilt of bent #1 could not be measured at the time of site visit). Ground failure surrounding bent #1 was not observed from this vantage point. View looking north (S36.847049°, W73.055443°; 1835 hrs on 3/15/2010).

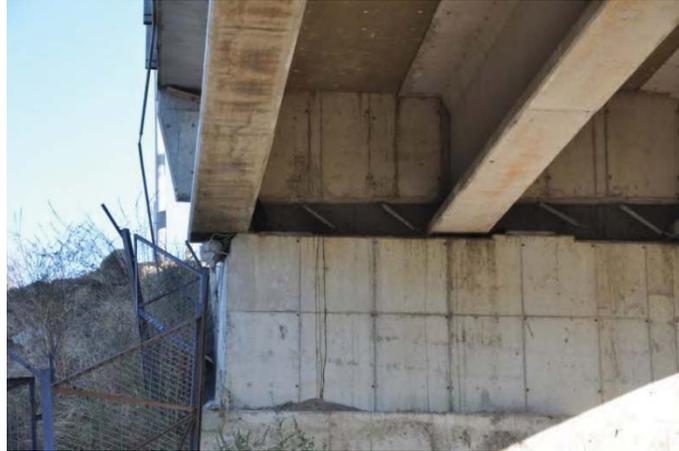
Figure 9.20. Transverse shift of deck relative to south abutment at the La Mochita bridge (S36.847547°, W73.054876°; 1834 hrs on 3/15/2010).

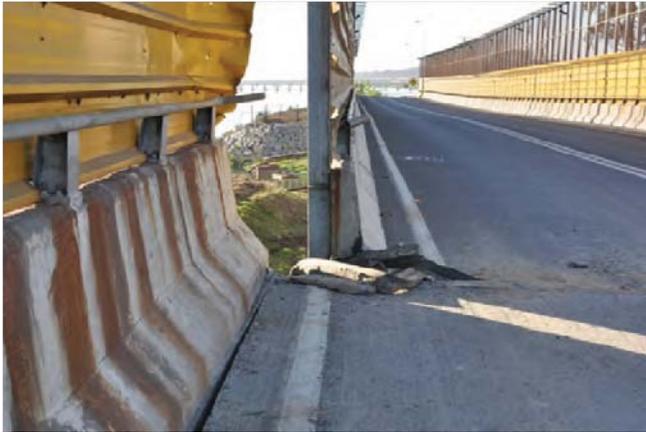
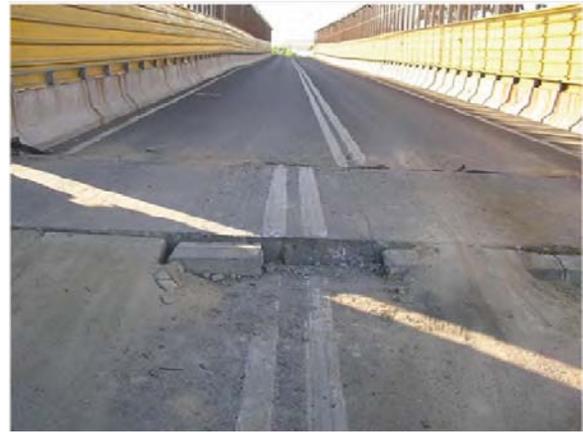
Figure 9.21. Mataquito bridge (a) Transverse gap developed between deck and south abutment. View looking north. (-36.847798°, -73.054797°; 1856 hrs on 3/15/2010), (b) Damage at the south abutment-road-deck interface due to transverse shift of the deck. View looking north. (S36.847761°, W73.054777°; 1856 hrs on 3/15/2010).

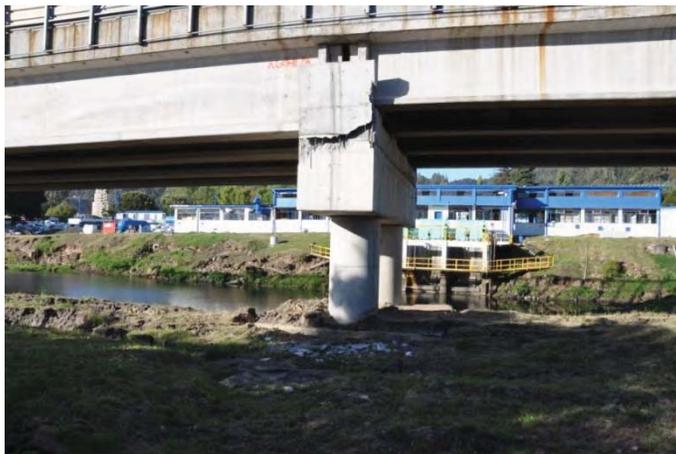
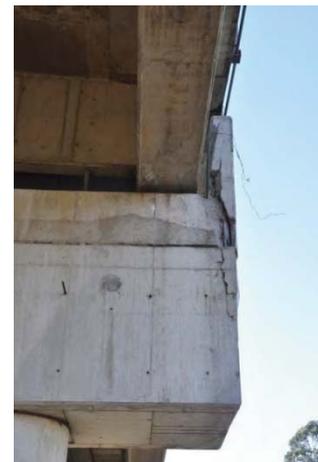
Figure 9.22. Damage to transverse shear keys at bent #3 due to movement of the La Mochita bridge (S36.847405°, W73.055084°; 1830 hrs on 3/15/2010).

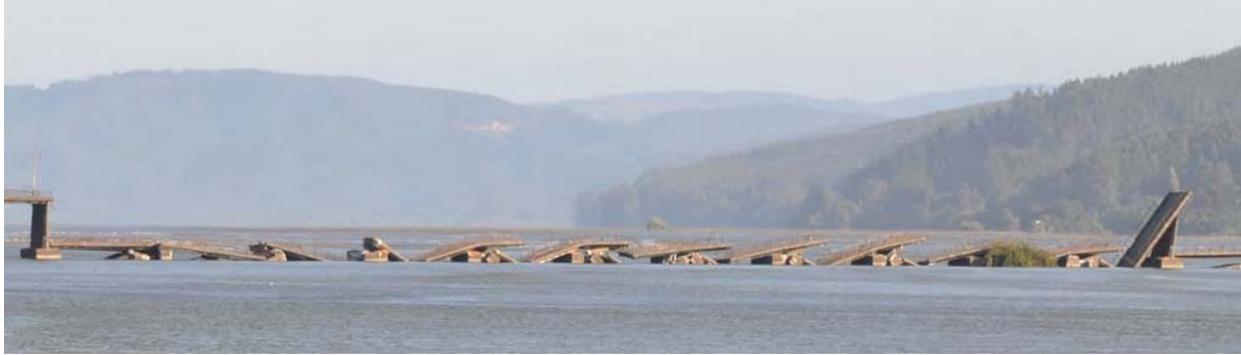
Figure 9.25. Puente Bi-Bio's collapsed slab sections and bridge bents (S36.837968° W73.062896° on 3/15/2010).

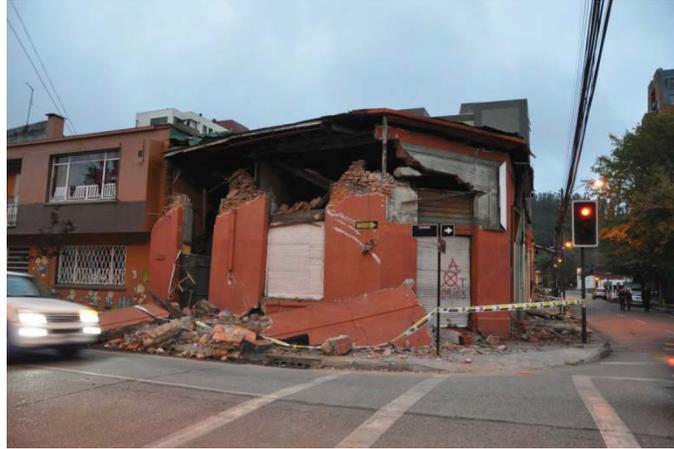
The City of Talca suffered significant damage to many buildings due to earthquake shaking. The damage was predominantly associated with low-rise adobe and unreinforced masonry construction (Figure 9.26). Taller, well-designed structures performed relatively well, with the exception of damage to exterior cladding and contents in the upper floors (RMS, 2010). The GEER team did not conduct an extensive survey of building damage within the city; rather the team focused on regions near the Rio Clara, which runs along the west edge of the city, extending north-south parallel with Route 5 (Figure 9.27). In addition, the team inspected areas along a branch of the river running east-west towards the southern edge of the city.

Figure 9.26. Typical construction type and observed damage within the city of Talca (S36.832375,W73.055439; 2016 hrs on 3/17/2010).

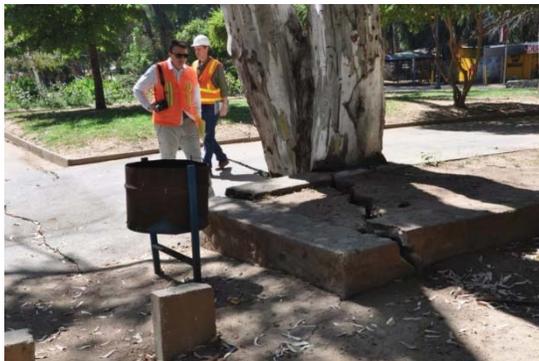
Local ground failure was observed approximately 50 m north of the Puente Rio Claro Nuevo (vehicular bridge) (Figure 9.30 and Figure 9.31). Two distinct regions were observed, a smaller lateral spread near shore (Figure 9.31), and a larger ground failure more characteristic of a soft clay failure confined within a park area (Figure 9.30). Soils near the shore area were predominantly gravely materials, likely with pockets of sand (one sand boil was observed at the near shore failure), whereas the park area was a soft clayey material. The ground failure extended approximately 90 m by 33 m north-south, however, it had no impact on the vehicular bridge, as it was open to traffic with no visible distress noted from the team's inspection on the east shore area. In contrast, the Puente Rio Claro Viejo (pedestrian bridge) suffered unseating of the longitudinally spanning girders and subsequent shear failure of the southern-most girder at a vista point near the mid-span of the bridge (Figure 9.32). From the team's limited access to the bridge it was not clear if the deck unseating was due to movement of the bent due to ground failure or excessive structural deformation at the bent.

Figure 9.30. Ground failure in a park area near the shore of the Rio Claro in Talca ($S35.419919^{\circ}$, $W71.682289^{\circ}$; 1408 hrs on 3/18/2010), views looking north and south, for left and right images, respectively.

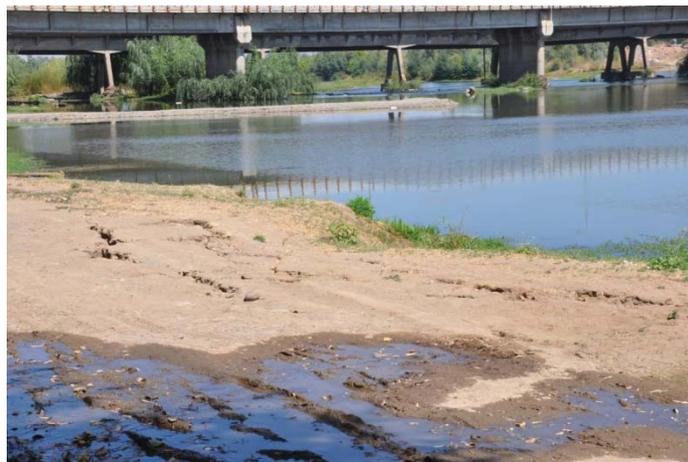
Figure 9.31. Near shore lateral spread on the western shore of the Rio Clara in Talca, view looking south. ($S35.419682^{\circ}$, $W71.682359^{\circ}$ on 3/18/2010). Both the pedestrian and vehicular crossing bridges are shown in the background.

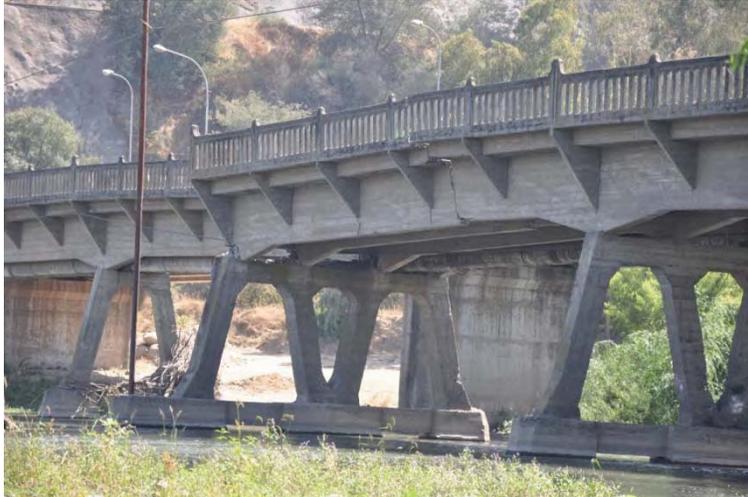
Figure 9.32. Deck unseating and shear failure of longitudinal spanning girders of the Talca pedestrian bridge at the vista area (S35.421044, W71.683197; 1354 hrs on 3/18/2010)

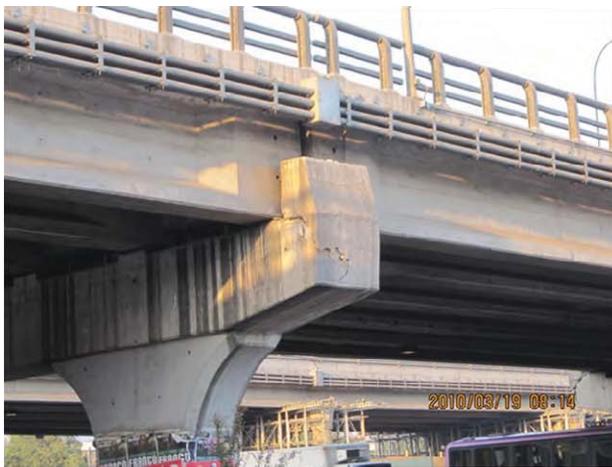
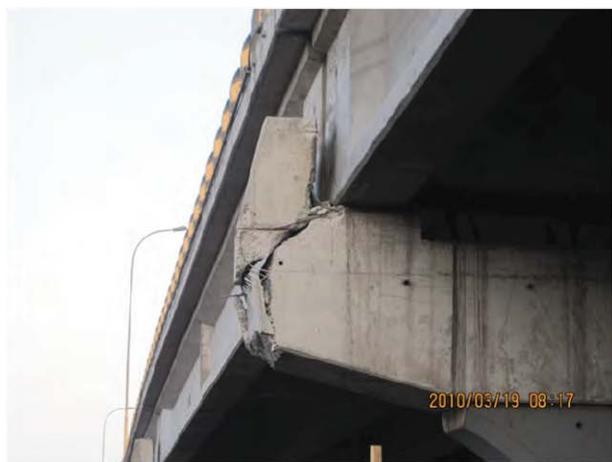
Figure 9.33. (a) Damaged shear key is an example of typical performance on bridges along this section of Vespucio Norte Expressway in Quilicura (S33.365585, W70.688657; 814 hrs on 3/19/2010), (b) Close up of damaged shear key along Vespucio Norte Expressway (S33.365893, W70.688584; 817 hrs on 3/19/2010).

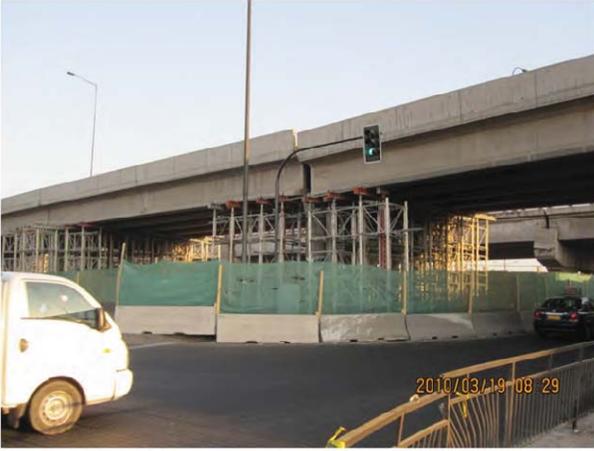
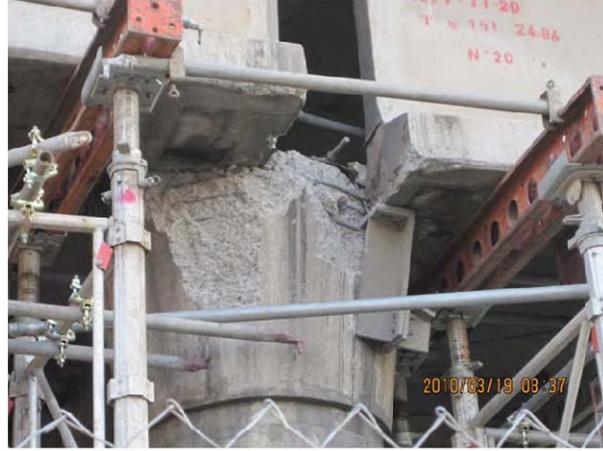
Figure 9.34 (a). Example of one of the newer under crossings that suffered damage along the Vespucio Norte Expressway. The right span became unseated due to excessive transverse movement (S33.36245, W70.688865; 829 hrs on 3/19/2010) (b) Close-up of shear key area on bent cap, with metal shear key or keeper bar hanging on right side of bent cap. Note complete unseating of I-girder on right side of bent cap (S33.366638, W70.689301; 837 hrs on 3/19/2010).

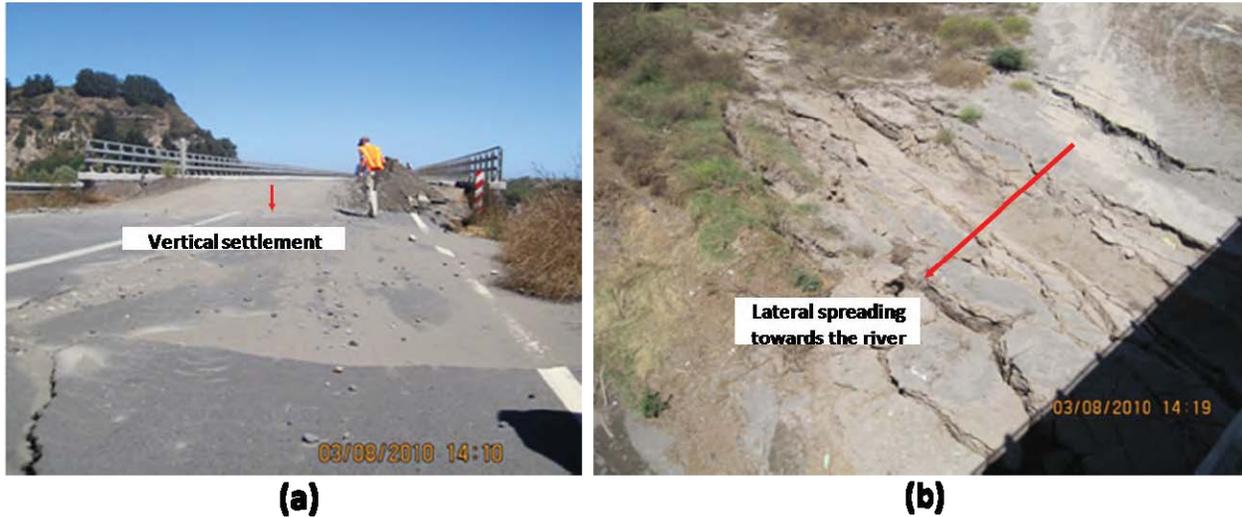
Built in 2008, the Mataquito Bridge is a two-lane 280 m-long reinforced concrete bridge, which runs in the north-south direction over the Mataquito River. Despite evidence of liquefaction at both abutments of this bridge, its overall seismic performance was good. No signs of structural damage due to lateral spreading were observed. Vertical settlement of about 50 cm was observed at the north approach fill, probably induced by liquefaction.

Figure 9.36. Mataquito bridge-(a)Settlement of approach fill at North end (b) Ground cracks at the South abutment due to lateral spreading (S35.051961, W72.163217, 1419 hrs on 3/08/2010)

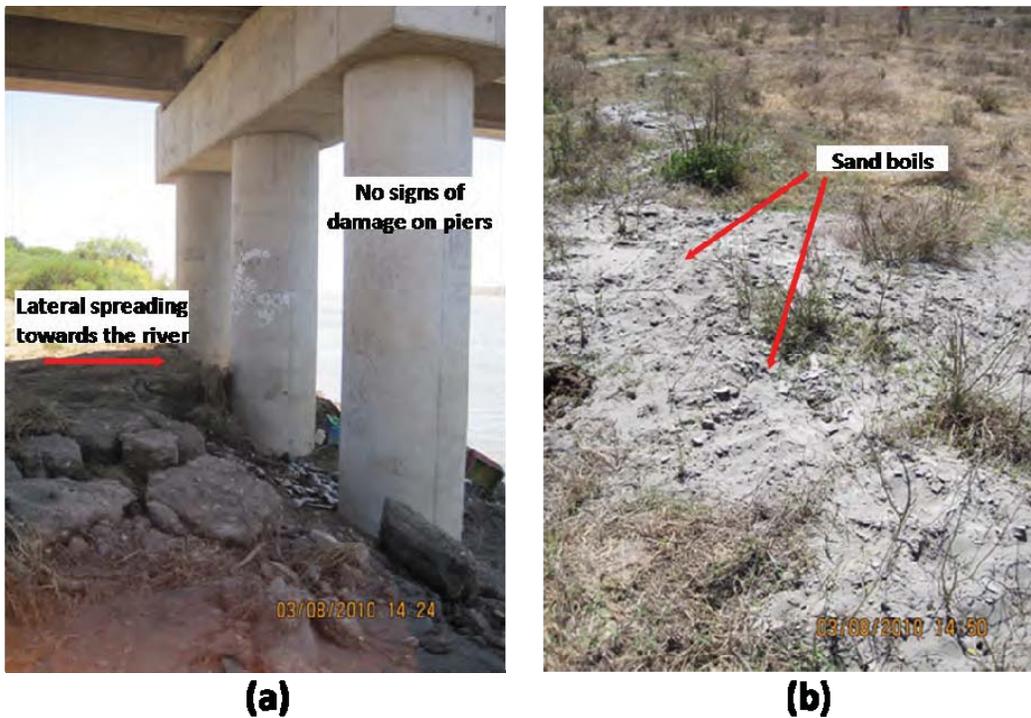
Figure 9.37. Mataquito bridge-(a) Blocks of soil crust against piers at the south end, (b) Sand boils at the north end of the bridge (S35.051961, W72.163217; 1450 hrs on 3/08/2010)

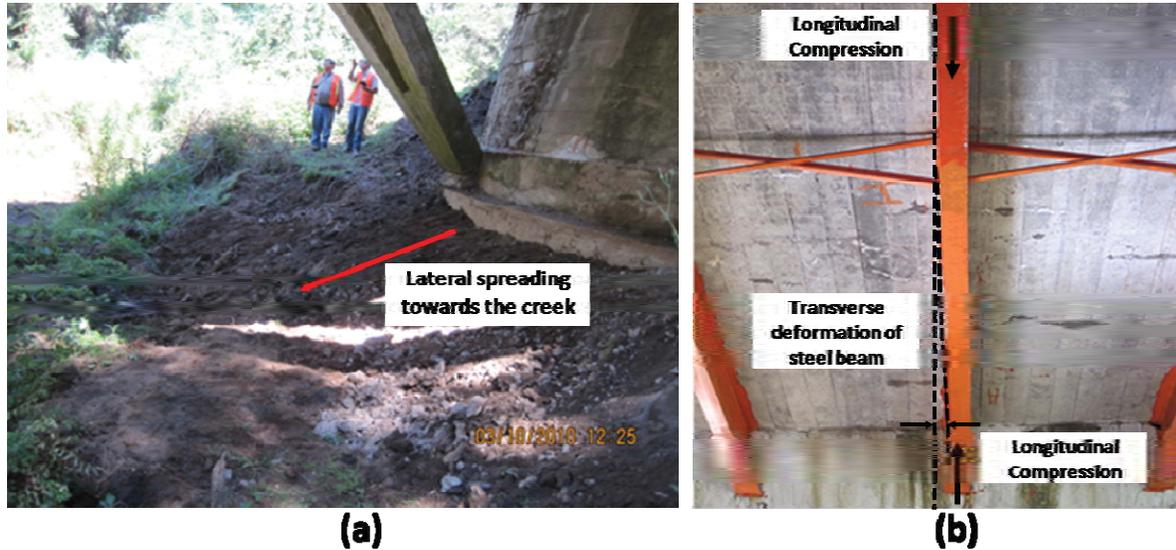
There was moderate damage of these bridges due to liquefaction and lateral spreading. These two-lane single-span old reinforced concrete bridges were close to each other. In these bridges the longitudinal movement due to lateral spreading of both abutments seemed to have compressed the bridges causing geometric distortion and moderate damage. The originally horizontal decks of the bridges ended up with a concave-down shape. Some transverse cracks were observed on the bridge deck due to this effect. Information provided by local authorities indicates that most of these bridges, if not all, have been recently surveyed as a part of a broad bridge assessment and improvement program, so there may be accurate survey points that could be used for future detailed analysis of the deformations.

Figure 9.38. Pulen Bridge-(a)Evidence of lateral spreading at the north abutment (b) Loss of longitudinal alignment of steel I-beam (S37.112036, W72.986902, 1225 hrs on 3/10/2010)

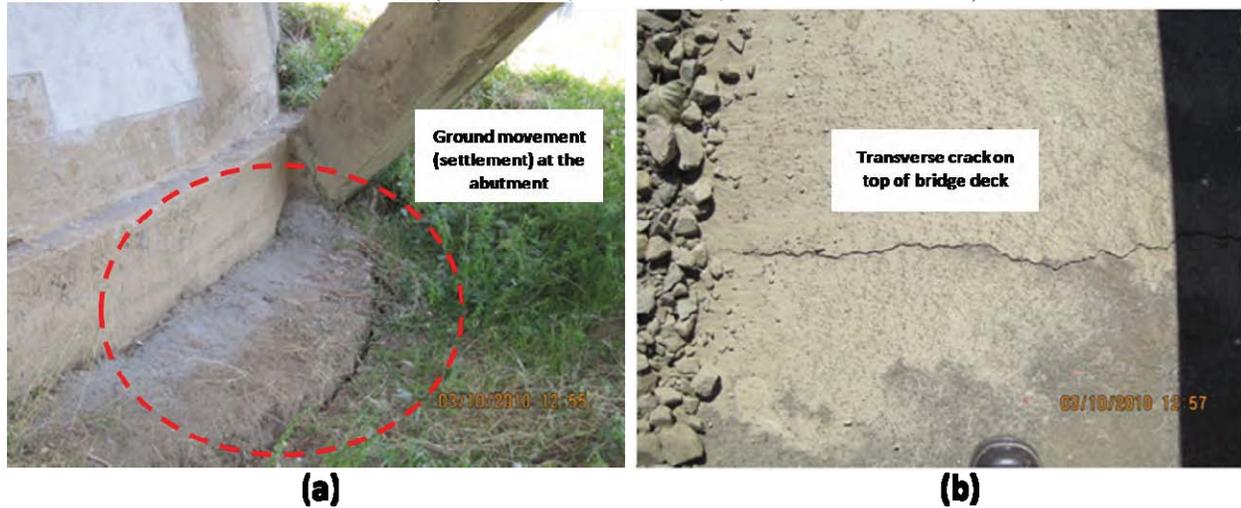
Figure 9.39. Patagual Bridge-(a) Ground movement at the abutment (b) Sidewalk crack in the transverse direction on the top of the bridge deck(S37.111325, W72.987583, 1257 hrs on 3/10/2010).

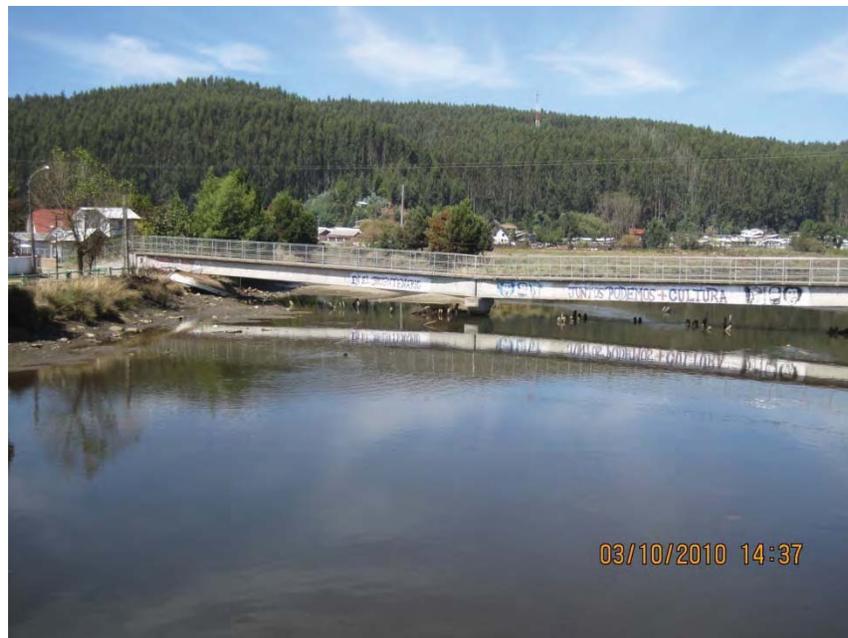
Two bridges were inspected in the Town of Laraquete, which is 50 km south of Concepción: A pedestrian two span bridge and an adjacent vehicular three span reinforced concrete bridge. The pedestrian bridge experienced damage due to foundation settlement of the middle bent with an estimated 0.50 m vertical deformation. Figure 9.41 shows the deformed bridge with noticeable inclination of the bridge deck. The adjacent reinforced concrete bridge, shown in Figure 9.40, suffered minor damage near the approaches due to pounding with the concrete structure and settlement due to poorly compacted fill. This bridge did not show evidence of foundation settlement.

Figure 9.41. Pedestrian Laraquete Bridge showing large settlement of middle pier (S37.166742° W73.184384°; 1437 hrs on 3/10/2010).

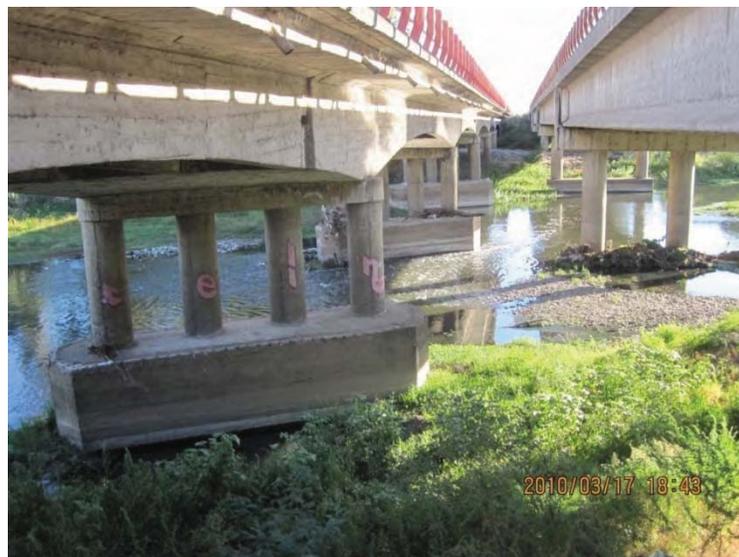
The EERI LFE Bridge Team observed this pair of bridges crossing the Rio Nebuco just South of Chillan along Route 5. The northbound bridge had a single dropped span, which had already been removed. The newer southbound bridge suffered only minor damage and was still in service handling both northbound and southbound traffic. The collapse was apparently a result of strong shaking. No apparent signs of liquefaction or lateral spreading and slope movement were observed.

Figure 9.43. This pair of bridges crosses the Rio Nebuco along Route 5 (S36.641846° W72.211264°; 1843 hrs on 3/17/2010).

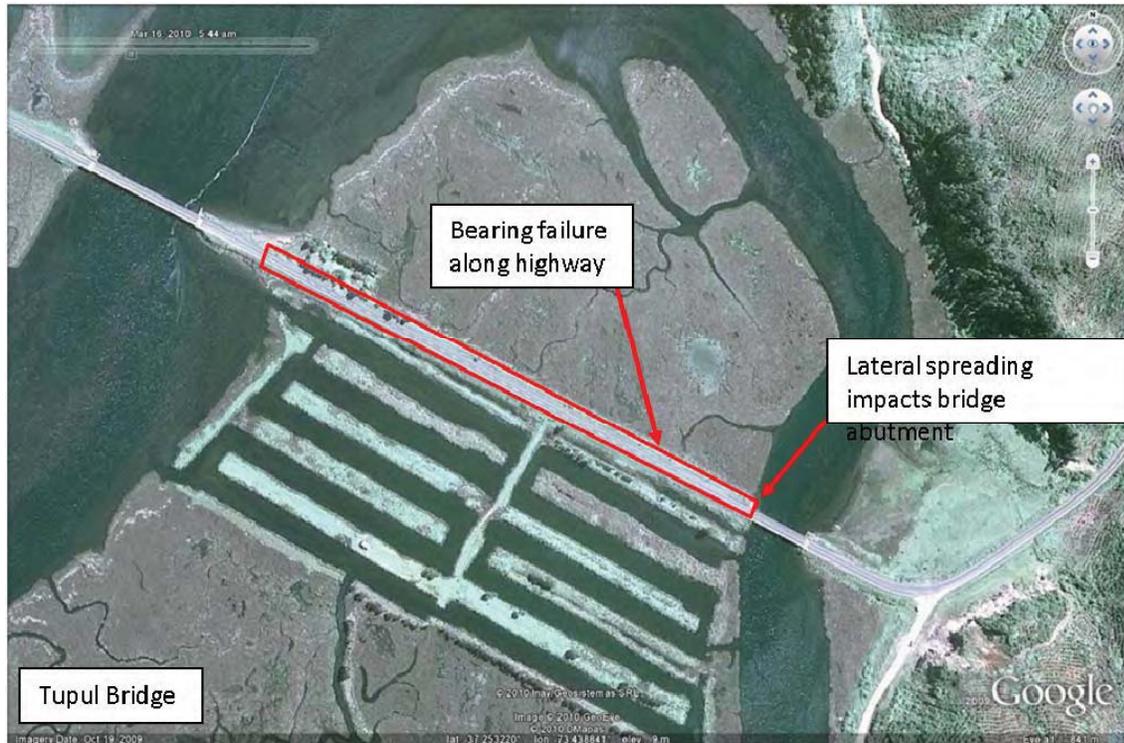
A roadway and bridge near the small town of Tupul were damaged due to ground failure. The layout of the bridge and roadway is shown in Figure 9.44. The roadway is about 0.33 km long and single span bridges cross the river on the east and west ends. Damage to the roadway and the bridge on the east end closed the road to traffic following the earthquake. The two lane roadway, with an embankment height of about 2 m, traverses a swampy, low-lying area adjacent to a small river which flows northward into the Pacific Ocean. Therefore, soils in this area are likely to be soft and saturated. The eastern bridge, which is about 50 m long, is supported by steel beams which rest on a seat type abutment.

Figure 9.44. Damage to roadway and bridge due to ground failure near town of Tupul, Chile (S37.254345°, W73.437021°).

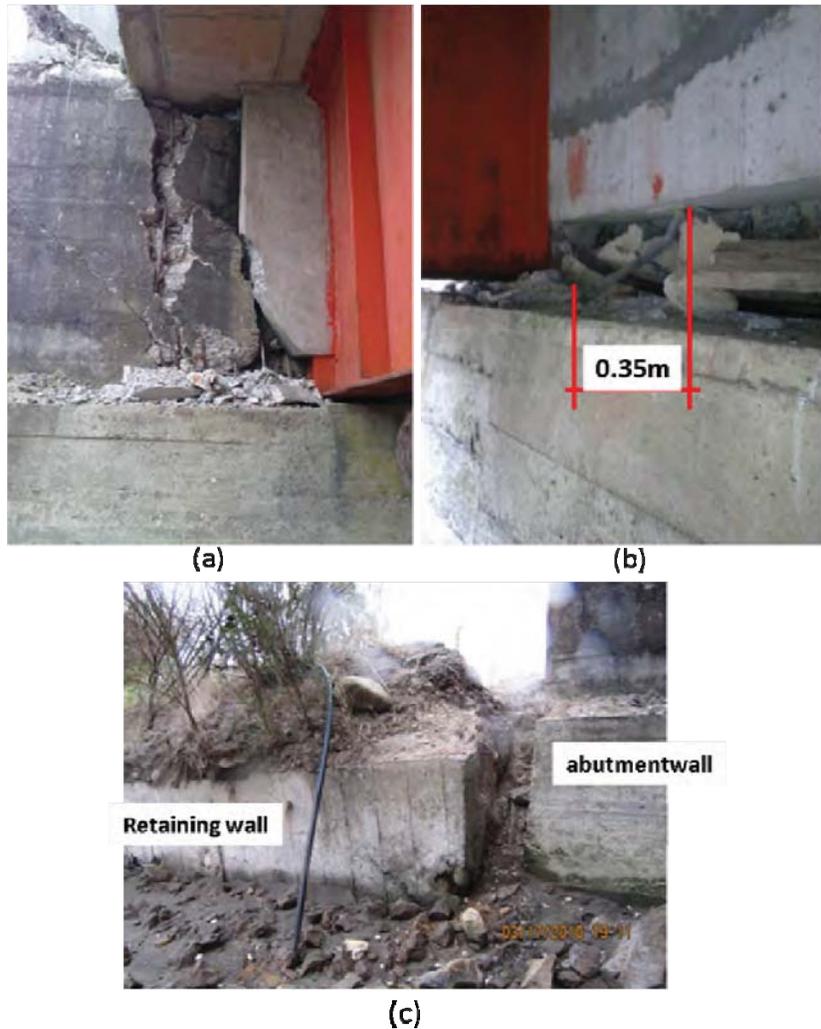
Figure 9.45. Damage to bridge abutment due to lateral spreading of soil around bridge abutment. (a) abutment wall movement relative to beams, (b) deformation of vertical restraining bar due to abutment movement relative to beams, (c) movement of retaining wall relative to abutment. (S37.254345°, W73.437021°; 1911 hrs on 3/17/2010)

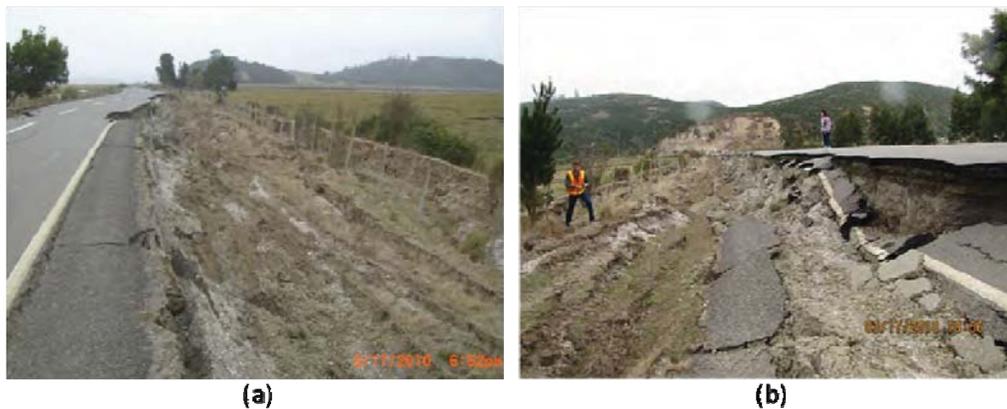
On both sides of the roadway, slumps developed along nearly the entire length of the roadway leaving vertical scarps 1.0 to 2.0 m in height as shown in Figure 9.46. The slopes on both sides of the roadway appear to have rotated downward causing an upward heave and rotation of the outer edge of the failure surface similar to a bearing capacity failure surface. In addition to the slumping along the sides of the road, the middle section of the road experienced lateral displacement towards the north as evidenced by the bow in the centerline of the road evident in Figure 9.46(a).

Figure 9.46. Photos showing scarps along both sides of the roadway due to bearing capacity failure in soil underlying the fill. Note lateral spreading in upper photo (S37.254161°, W73.437577° on 3/17/2010)

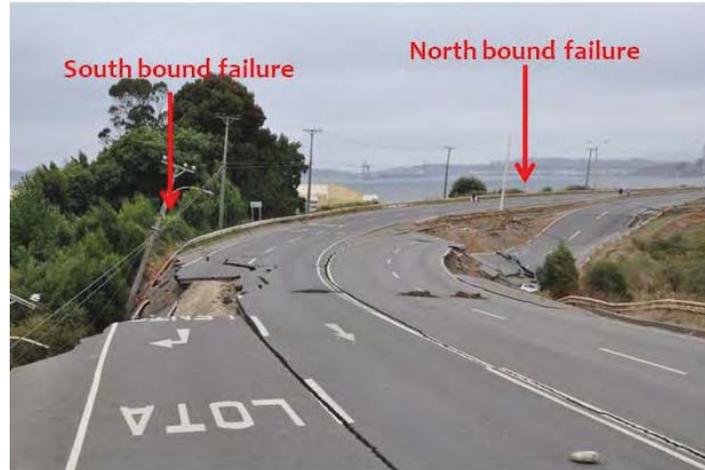
The north bound ground failure appeared to be deeply seated, perhaps due to softening of the foundation materials. It was not clear whether the south bound failure was due to a deep seated foundation failure or due to poorly compacted earth fill in the embankment section. A gray sandy fill overlaid by compacted clay fill was used in the elevated road embankment. The roadway elevation was approximately 10–15m above the valley area (10 m nearest to the overcrossing bridges, with high point above the housing development area). The bridge overcrossings, and therefore the road embankments, each of the north and south bound sections may have been constructed at different times, as evident in the differences in construction type of the bridges (Figure 9.50(a)). The neighboring elevated railroad failure is characterized by a slumping and spreading of the elevated section, which is likely due to movement of the compacted fill (Figure 9.50(b)). The railroad was approximately 5-7 m above the low lying marshy area along its failure zone.

Figure 9.48. View looking north on route 160 showing south bound and north bound failure areas (S37.0744°, W73.1480°; 1220 hrs on 3/16/2010).

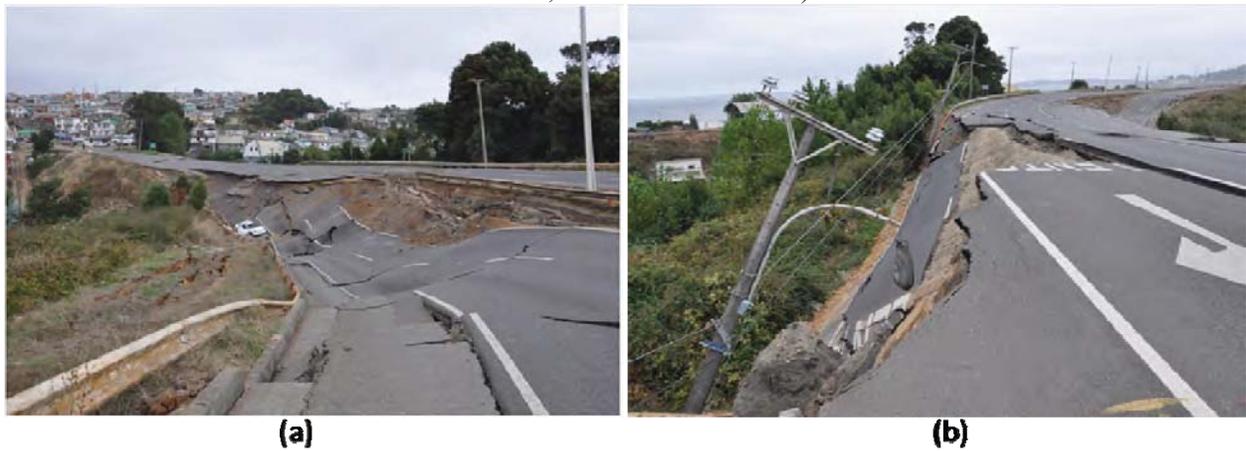
Figure 9.49. Lota (a)View looking south on route 160 showing north bound failure area (S37.0730°,W73.1475°; 1145 hrs on 3/16/2010) (b)View looking north on route 160 showing south bound failure area (S37.0746°, W73.1479°; 1215 hrs on 3/16/2010).
