9.0 EFFECTS OF GROUND FAILURE ON BRIDGES, ROADS, RAILROADS, AND LIFELINE SYSTEMS

9.1 Introduction

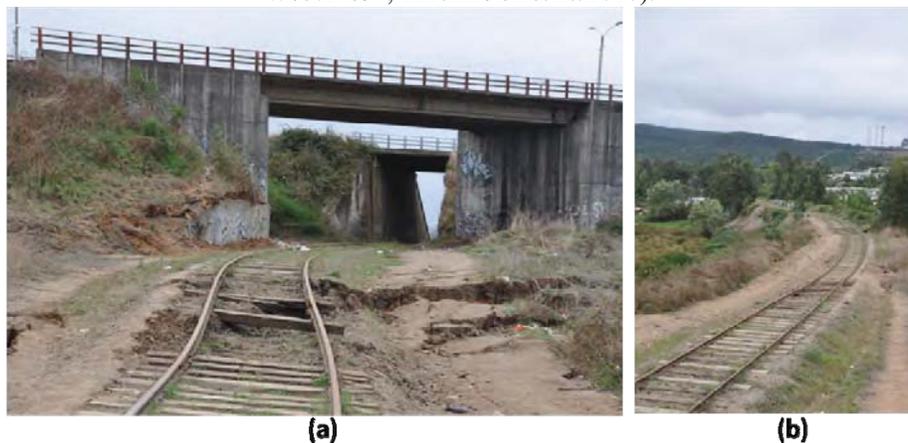
Figure 9.50. Lota (a)Slab and girder-type overpasses at northern end of road embankment failure area, showing railroad and supporting ground settlement. View looking west. (S37.0729°, W73.1469°; 1150 hrs on 3/16/2010), (b) Ground failure below elevated railroad east of road embankment failure. (image looking east; S37.0727°, W73.1471°; 1150 hrs on 3/16/2010)

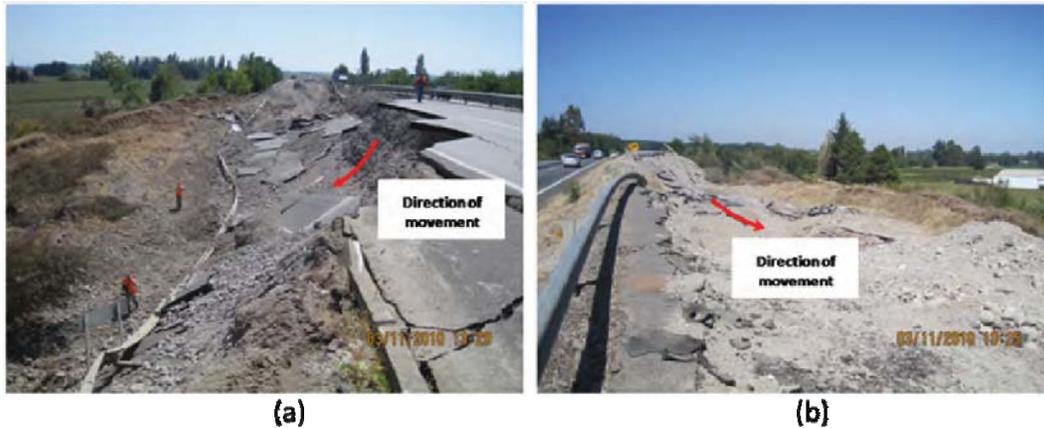
Two collapsed embankment fills were identified near Copihue and Parral. The first, shown in Figure 9.51, occurred on a straight section of Ruta 5 located ~ 8 km North of Parral (S36.0796 W71.7881). The Southbound lanes collapsed to the West and appeared to involve a shallow translational slide in near surface foundation soils as evidenced by the location of the failed soil mass including a mound of soil pushed up at West toe of the embankment (Figure 9.51a). The embankment failed along a length of approximately 150 m at a location where a low lying softer soil area was located at the toe.

Figure 9.51. This embankment fill collapsed together with an overhead near Copihue, north of Parral, closing the South bound of Route 5 (a) View from the South, (b) View from the North (S36.087891, W71.791513, 1325 hrs on 3/11/2010)

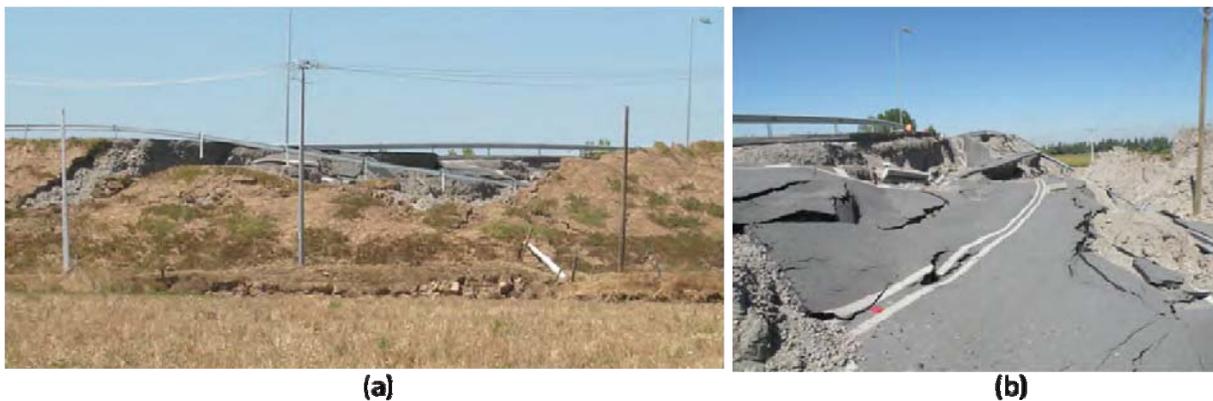
The second failure, shown in Figure 9.52, occurred on an overpass of Ruta 5 located ~ 13 km North of Parral. (S36.0347 , W71.7558). The overpass embankment was curved and the embankment failed over a length of about 80 m towards the outside of the curved section. Again, the failure appeared to involve a shallow translational slide in the near surface foundation soils as evidenced by the intact failed soil mass and the mound of soil pushed up at the toe (Figure 9.52a). Foundation soils in the region appeared to be relatively competent (unlike the above case) suggesting possible elevated pore pressures in the foundation soils played a role in the observed failure with 3-D effects leading to failure to the outside of the curved embankment section as opposed to the inside of the embankment. The outside section of the slide mass remained completely intact as evidenced in Figure 9.52b.

Figure 9.52. Curved overpass embankment failure 13 km North of Parral (a) Translational 3-D slide failure, (S36.0343 W71.7568; 1405 hrs on 3/11/2010) and (b) Failed outside of the curved embankment (S36.0347 W71.7558; 1409 hrs on 3/11/2010)

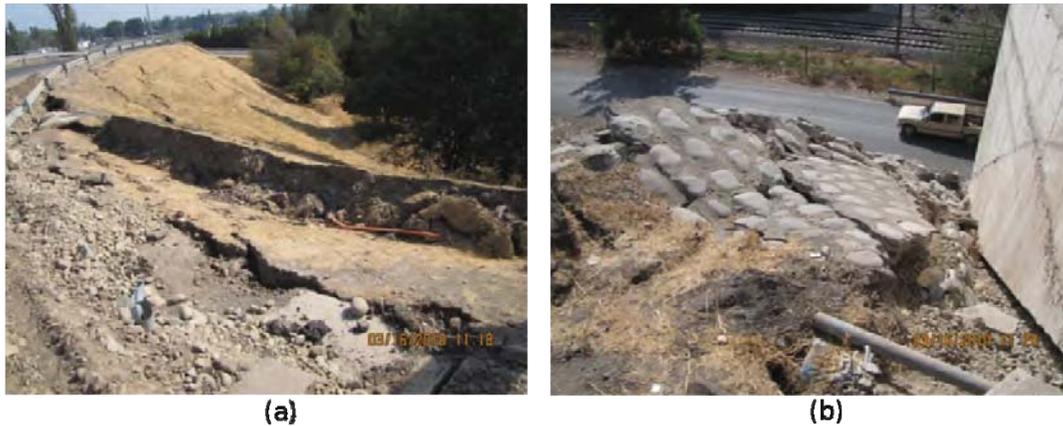
Abutment and embankment failures were common along Route 5. Figure 9.53 and Figure 9.54 show typical highway failures due to poor compaction of the embankment fill and abutments near Paine 62 km South of Santiago. The same scenario repeated at multiple sites. In contrast, mechanically stabilized retaining structures performed exceptionally well. Figure 9.53 shows the failure of an overpass bridge. The figure shows cracks on the sloping ground that propagated away from the abutment, and reduced in size away from the bridge. It seems cracks succeeded the abutment failure. The structural damage of the overpass was caused by differential settlement of the supports. Figure 9.54 shows the failure of the highway shoulder and pavement due to poor compaction of the fill material.

Figure 9.53. Highway 5 crossing near Paine; (a)View of bridge approach from East ($S33.854592^{\circ}$ $W70.747687^{\circ}$; 1118 hrs on 3/16/2010); (b) View of damaged bridge abutment ($S33.854211^{\circ}$ $W70.747784^{\circ}$; 1120 hrs on 3/16/2010)

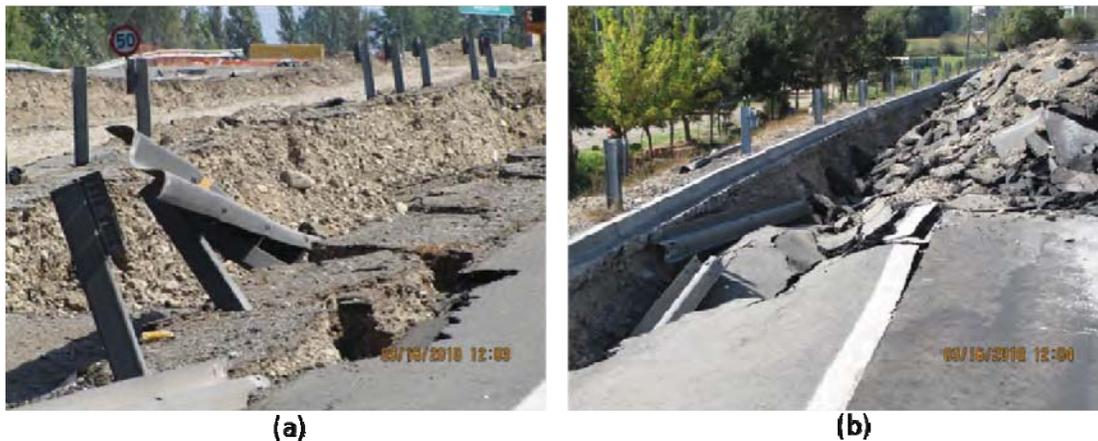
Figure 9.54. Highway 5 failure near Paine; (a)shoulder settlement due to poorly compacted soil ($S33.864897^{\circ}$ $W70.742222^{\circ}$ 1203 hrs on 3/16/2010), and (b) road failure due to poorly compacted soil ($S33.864897^{\circ}$ $W70.742222^{\circ}$; 1204 hrs on 03/16/2010)

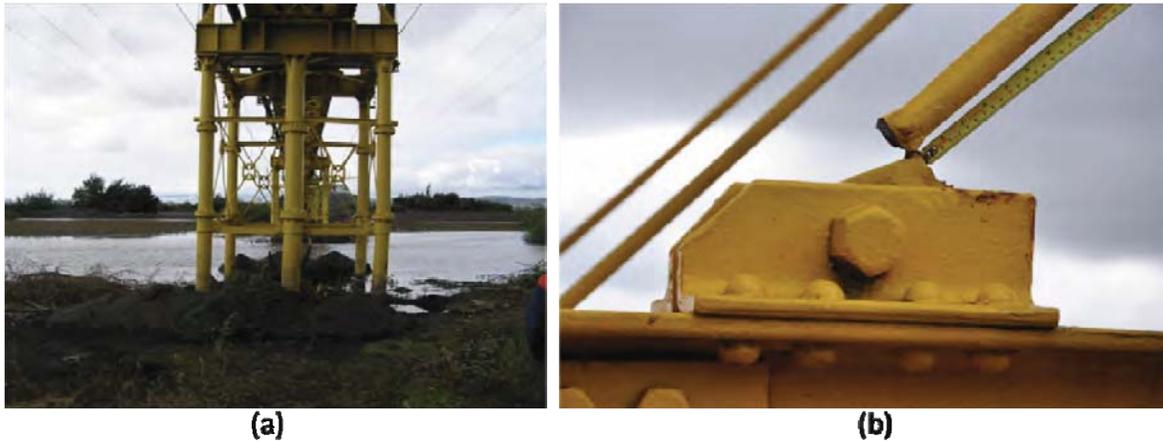
The Bio Bio river railroad bridge is one of the oldest crossings of the Bio Bio river. Originally built in 1889 m, it was completely retrofitted in 2005. This railroad structure is composed of parallel top and bottom chords separated by diagonal and vertical members in a Warren truss arrangement. Three hundred and seventy pillars support the structure covering a length of 1889 m. The bridge was damaged during the 2010 Chile earthquake due to strong shaking and possibly lateral spreading of the river banks. Of the 370 pillars of the bridge, 19 were damaged during the earthquake and several portions of the rail were bended or miss-aligned (Figure 9.56). Visual inspection of pillars near the West abutment seems to indicate several piles moved in the lateral direction and rotated (Figure 9.55). The rail lines were moved out of alignment as shown in Figure 9.53.

Figure 9.55. Bio Bio Railroad crossing (a) Pillars move and rotated during earthquake (b) Detail of broken crossbar, (S36.836075° W73.086969°; 1717 hrs on 3/17/2010)

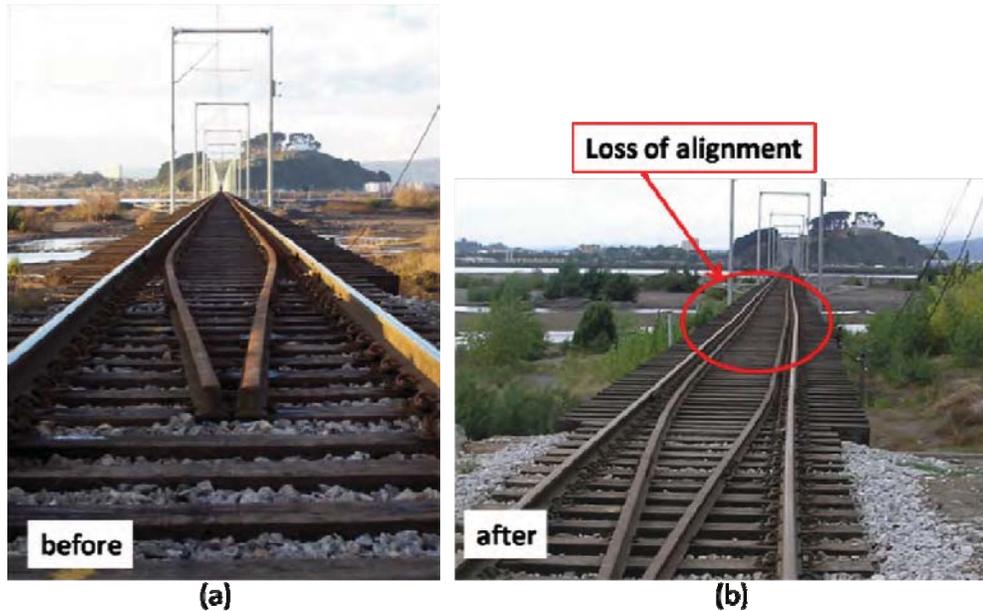
Figure 9.56. Bio Bio Railroad crossing (a) rails aligned before earthquake, (b) rails bended after earthquake (S36.836097° W73.087094° on 3/17/2010)

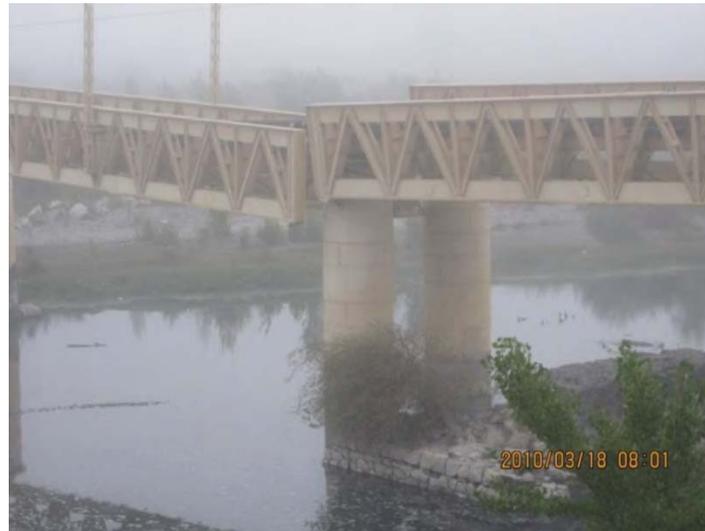
The EERI Bridge team observed the unseated railroad bridge span shown in Figure 9.57 approximately 330 km south of Santiago. This appeared to be the result of strong shaking, as no signs of liquefaction were observed. The Route 5 highway bridge was undamaged. An adjacent highway bridge was out, but demolished prior to the earthquake (S36.004136, W71.726193). Approximately 217 km south of Santiago, a railroad bridge crossing the Rio Claro was apparently undamaged, though the approach fills settled over 0.5 m, resulting in separation of the tracks from the support.

Figure 9.57. Unseated railway bridge span near Longavi from excessive transverse movement (S36.004136, W71.726193, 0801 hrs on 3/18/2010)

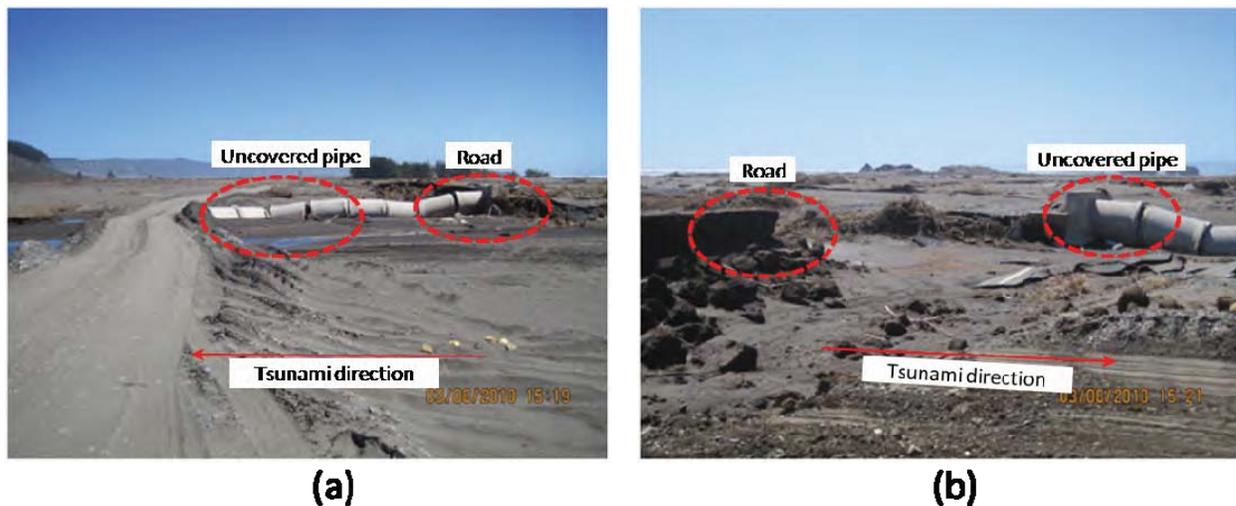
In this area, the tsunami caused most of the damage, washing off the road and uncovering a concrete pipe (Figure 9.55). Considering the extent of the damage in this zone, the pipe did not distort very much. This part of the road, however, was totally destroyed.

Figure 9.58. Failed culvert pipe: (a) View from the north, and (b) View from the south (S35.115611, W72.203245, 1519 hrs on 3/8/2010)
