ULTRA-HIGH RESOLUTION VISUALIZATION OF GROUND DEFORMATION AND STRUCTURAL FAILURE USING GROUND-LIDAR: EXAMPLES FROM THE NIIGATA KEN CHUETSU EARTHQUAKE

Robert KAYEN¹, Brian COLLINS², Peter DARTNELL¹, Gerald BAWDEN³,
Scott ASHFORD⁴, Nicholas SITAR²

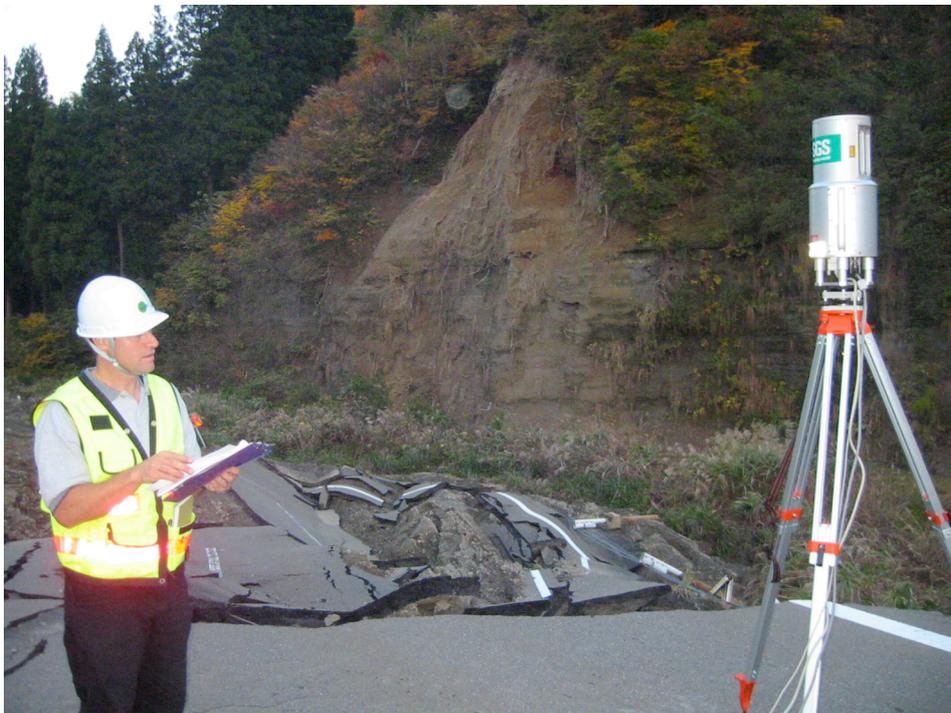
Figure 1. The USGS LIDAR unit, here, scanning of a road embankment failure on Route 252, west of Horinouchi-Cho. The system can be easily transported by vehicle or backpack to study sites, and travels as checked baggage.

To image a surface, the scanner is transported to the site in a travel-bag or backpack. The unit weighs 13 kg, and the accessory cables, tripod, battery and laptop can double the weight. We place the scanner on a tripod in front of the object of interest and connect the device to a battery and laptop computer for data storage and visualization. Typically, the scanner is set up upright with the unit rotating horizontally, though to image objects overhead or below, the scanner can be mounted sideways. For example, the scan of the Juestsu railway tunnel-portal failure at Kita-Horinouchi (discussed later in Figure 5) included sideways scans of the tunnel roof.

During our reconnaissance of the 23 October 2004 Niigata Chuetsu, Japan earthquake, we visited sites of damaged roadways, structures, and displaced ground and collected data from approximately thirty individual laser-scan setups. The Niigata Chuetsu earthquake was particularly damaging to the roadways and hill-slopes in the mountain country above the Shinano and Uono rivers. Roadside embankment failures were ubiquitous throughout the mountainous areas. An example of one such embankment failure on a steep mountainous section of Highway 252, west of Horinouchi Town is presented in Figure 1 and 3.

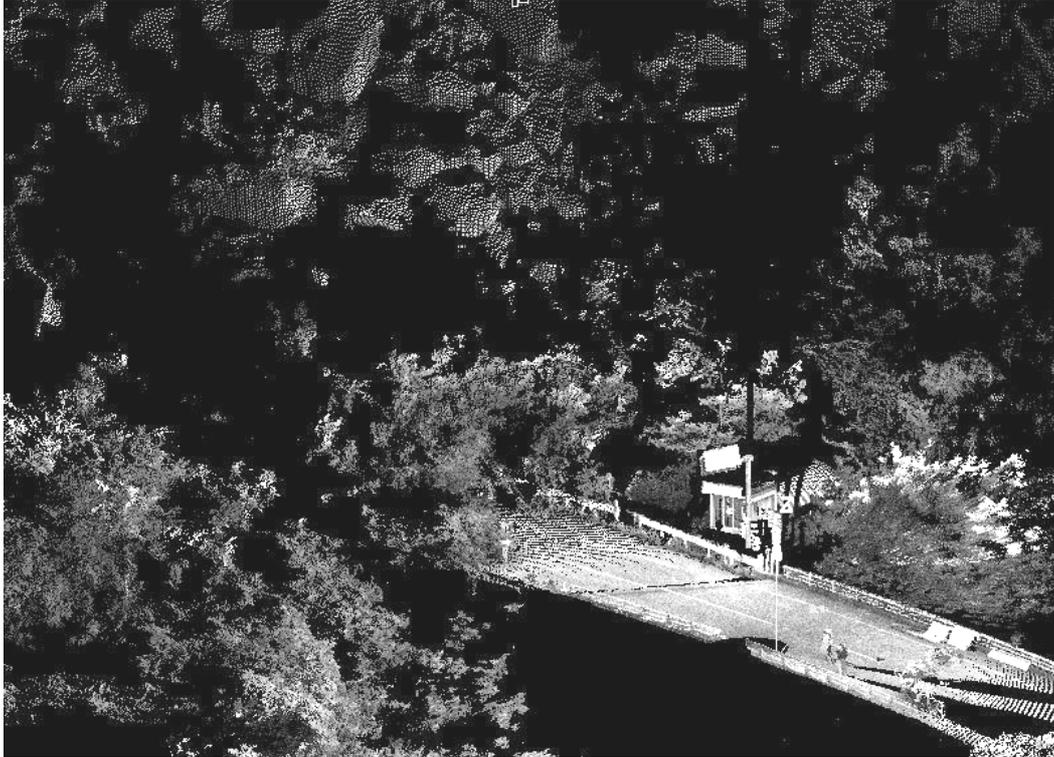
Figure 2. The landslide at White Rock, Ojiya swept portions of the highway, bluff, and vehicles into the Shinano River. Here, on the south side of the slide, the landslide buried the highway.

The 3-D laser scanners cannot see behind objects, and so the first surface encountered casts a shadow over objects behind it. For example, in a scan of the boulder-field of the White Rock Landslide at Ojiya, Japan (Figure 2), the near-field objects cast shadows over the debris located behind them. As the grazing-angle of the laser point decreases, proportionally larger shadows are cast on the ground behind the target. To minimize shadow zones and get full coverage of the target surface, the scanner is

A final example is of a natural slope failure is the White Rock landslide, which dislodged rock debris along a steep un-buttressed cliff corner on the banks of the Shinano River, at Route 17. This huge rockslide at Myoken, Ojiya-Shi, dislodged a n entire cliff-face of soft and friable weathered mud stone with laminated sand. This slide killed several people driving along on the National Road 17 along the Shinano River. The rock slope, a portion of the highway cut-and-fill, and five vehicles were swept into the Shinano River in a catastrophic collapse of the bluff. Eight LIDAR scans were taken on the north, western and southern sides of the slide to characterize the volume, runout and morphology of the slide. The roadbed on the north side of the slide collapsed into the river. On the south side of the landslide, block debris completely covered the roadbed just north of the highway bridge (Figure 2). The height of the cliff

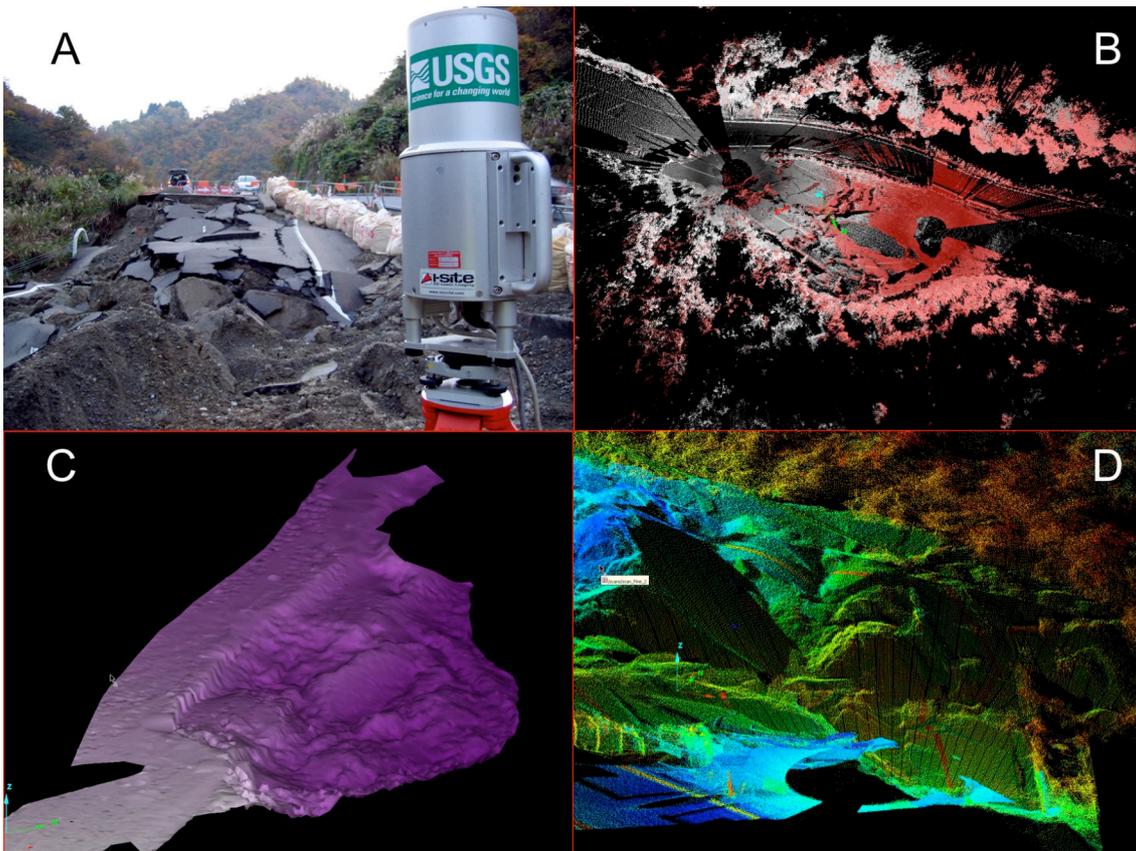
Figure 3. Processing procedures for ground-LIDAR technology: (A) scan target; (B) merge multiple scans; (C) render the solid surface model; (D) visualize and analyze geometry. The direction arrows are the local orientation of the scanner and not the absolute orientation.

Here, a two-way, two-lane road, built on the northern side of a steeply sloped river-incised canyon, failed toward the south into the bottom of a narrow ravine. Two scans were set up on the east and west ends of the failure to minimize the shadow zones. In the four frames of Figure 3, we show the processing procedures for producing a surface model: (A) scan the target from multiple perspectives; (B) merge and register the scans; (C) filter out vegetation and render the surface model; and (D) visualize and analyze surface model with overlay of raw point data. With this product, we can make a variety of geometric measurements of the ground failure and have a data set that can be differenced against pre-event topographic survey drawings of the embankment.

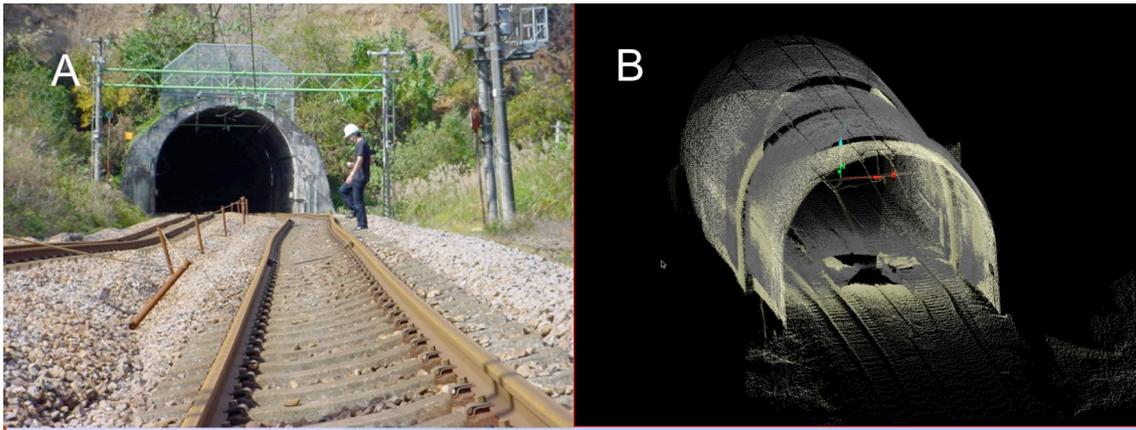
Figure 4. Photograph (A) and LIDAR image (B) of damage to the Juetsu Railroad portal at Kita-Horinouchi. Lateral displacement of the portal relative to the tunnel wall and distress of the rail track is precisely recorded in the LIDAR scan (B).

An example of structural damage recorded by the LIDAR unit is presented in Figure 4, collected in the damaged portal of the Juetsu railroad tunnel, north of the town of Horinouchi in central Niigata prefecture. The portal is founded on a poorly compacted embankment fill that settled during the earthquake. The portal pulled away from the tunnel, opening a gap, and settled laterally toward the east (downslope). Vertical settlement was more pronounced on one side of the portal causing it to undergo a minor rotation. A photograph of embankment and tunnel damage is presented in Figure 4A. In the interior of the tunnel, displacement of the portal was observed in the walls and ceiling. An oblique view of the LIDAR point-cloud data can be seen on the right in Figure 4B. Here, the portal (front section) and tunnel are viewed from above and south of the portal entrance. The left-lateral offset of the portal relative to the tunnel is clearly visible in the LIDAR model. In the LIDAR imagery, precise centimeter-scale measurements can be made of the three-dimensional deformation of the structure. At this tunnel, we measure 36 cm of separation of the portal and 21 cm of left-lateral displacement. Displacement of the portal and failure of the gravel embankment also resulted in deformation of the railway tracks, clearly visible in the LIDAR scans.

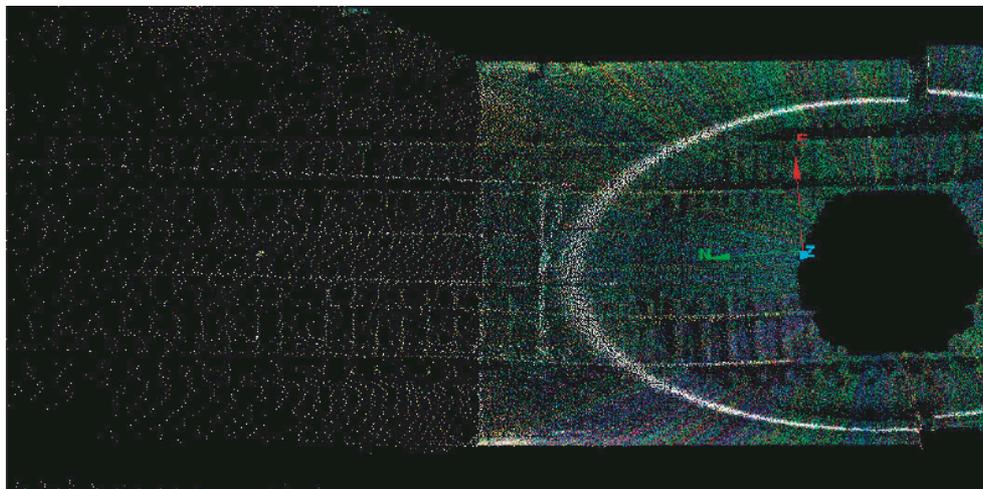
Figure 5. Plan view perspective of the LIDAR image of damage to the Juetsu Railroad portal at Kita-Horinouchi. Portal displacement is 21 cm lateral-toward the left. The direction arrows are the local orientations of the vertical and horizontal planes about the scanner and are not absolute directions.

We use 3-D imaging software to rotate the LIDAR imagery into plan view looking down from above through the roof of the portal (Figure 5). In this view, the portal separation (35 cm) and left-lateral displacement (21 cm) from the tunnel (right) can be seen at the top and bottom of the tunnel wall. The data-hole in the center is the non-illuminated area beneath the tripod.
