Morphological Monitoring on the Elwha River delta - 2011 Update

11/22/2011

Morphological Monitoring on the Elwha River delta – 2011 Update

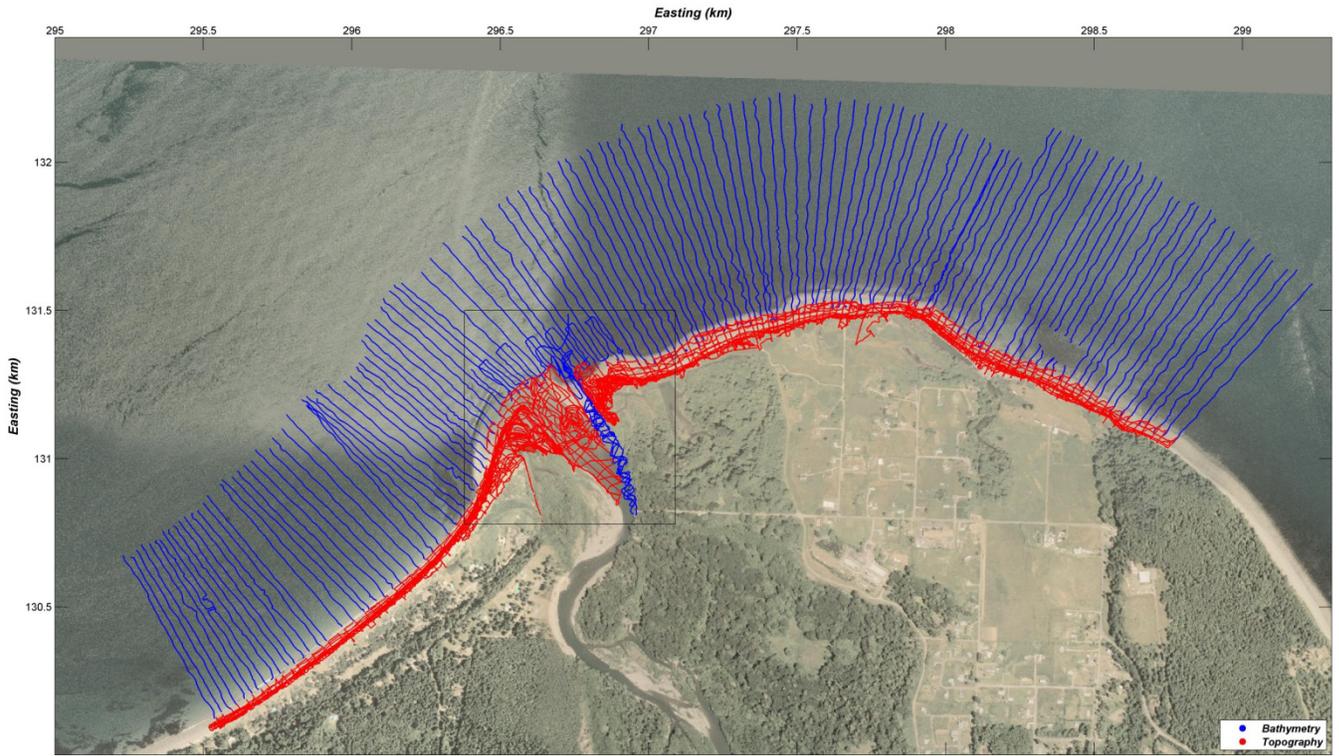
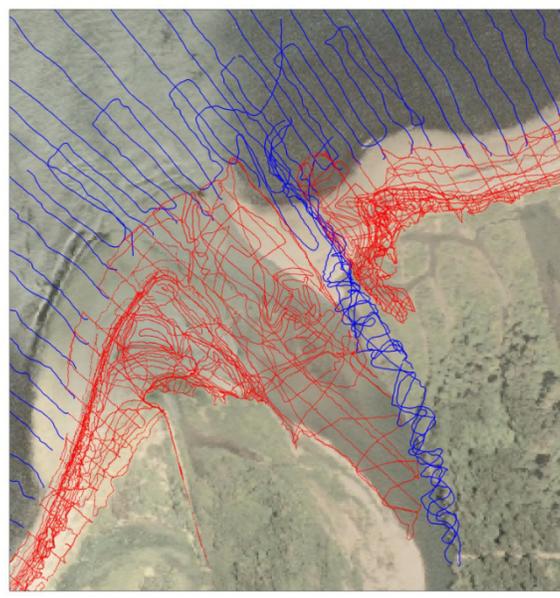
Figure 1. Maps of survey coverage showing the location of beach topography (red) and nearshore bathymetry (blue).

On August 25-26, 2011 a team of scientists from the USGS Pacific Coastal and Marine Science Center, Washington State Department of Ecology, and Washington Sea Grant participated in a survey (USGS Field Activity W-6-11-PS) to collect nearshore bathymetry and beach topography on the Elwha River delta (Table 1). A total of 98 km of nearshore bathymetric data and 120 km of topographic data were collected over the two-day survey. Environmental conditions were favorable resulting in excellent coverage of the beach and nearshore region (fig. 1).

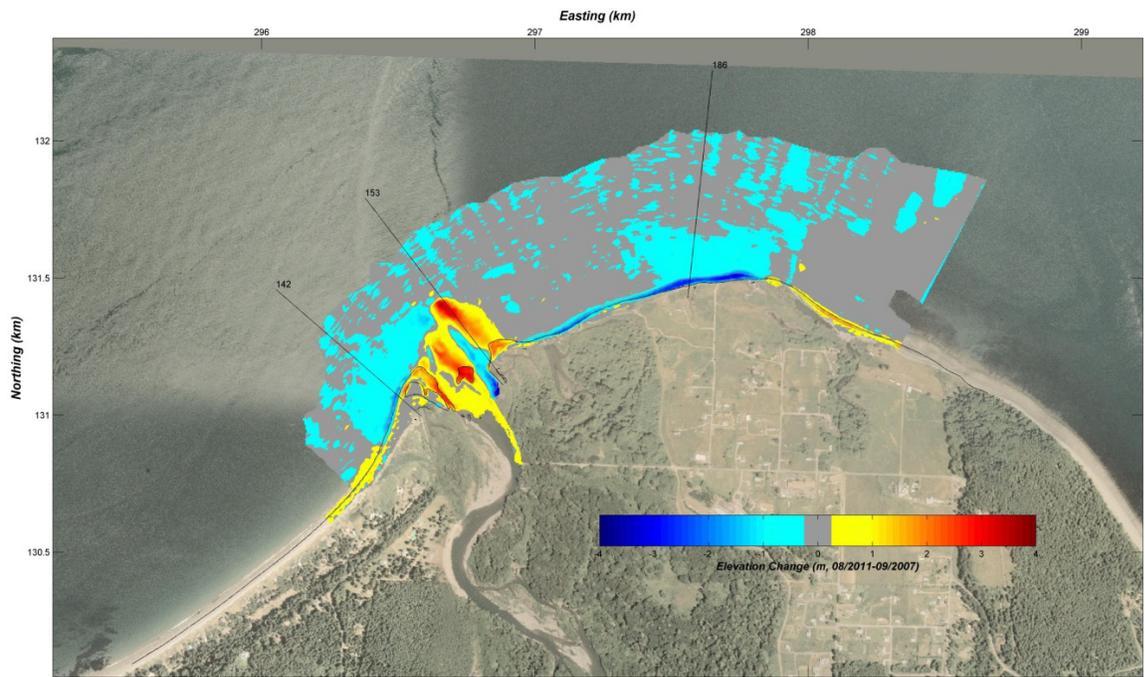
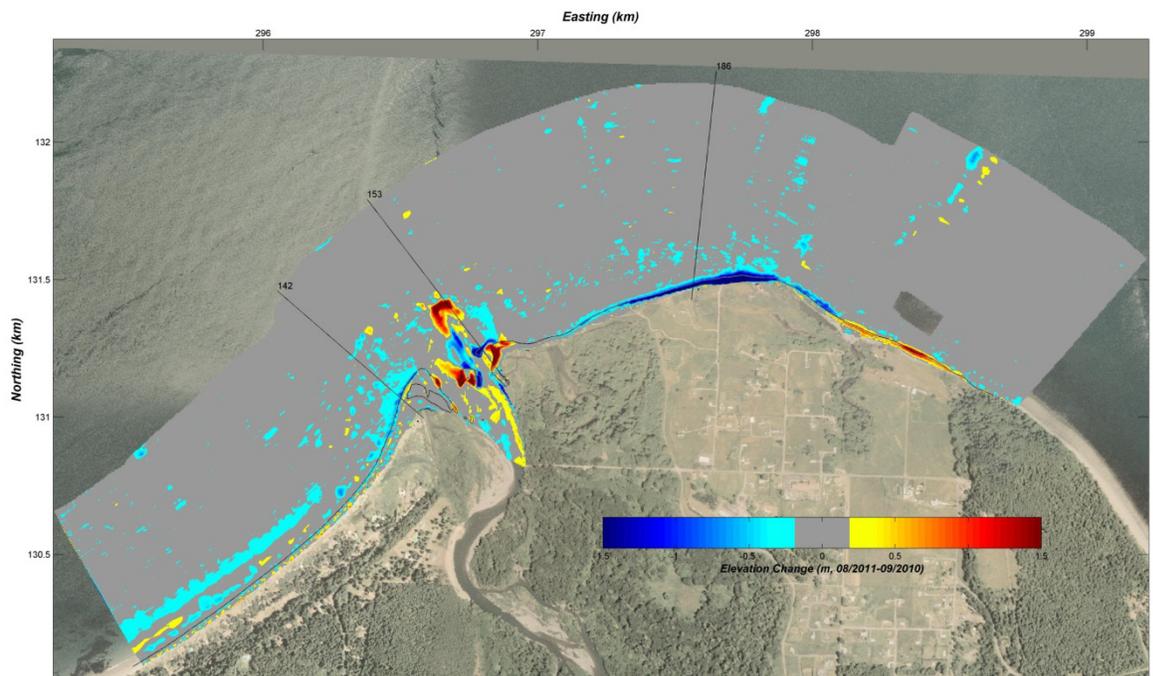
Figure 2. Morphological change observed between 2011 and 2007 (top) and 2011 and 2010 (bottom). Note the difference in color scale. Red is accretion and blue is erosion.

Morphological changes observed between 2007 and 2011 are shown in figs. 2-6. The beach and nearshore area immediately to the west of the current river mouth has steadily eroded since 2007. As the river mouth shifted to the east (fig. 6), the supply of sediment to this region has likely declined resulting in net erosion (fig. 3). Offshore of the current river mouth, the subaqueous delta has prograded and the profile reveals complex changes as a result of the shifting configuration of the river mouth (fig. 4). Along the central axis of the delta (near Charles Road), the rate of beach erosion has increased in the past two years (fig. 5). Erosion in this area is not limited to the beach, but is also evident at depths of up to 6 m.

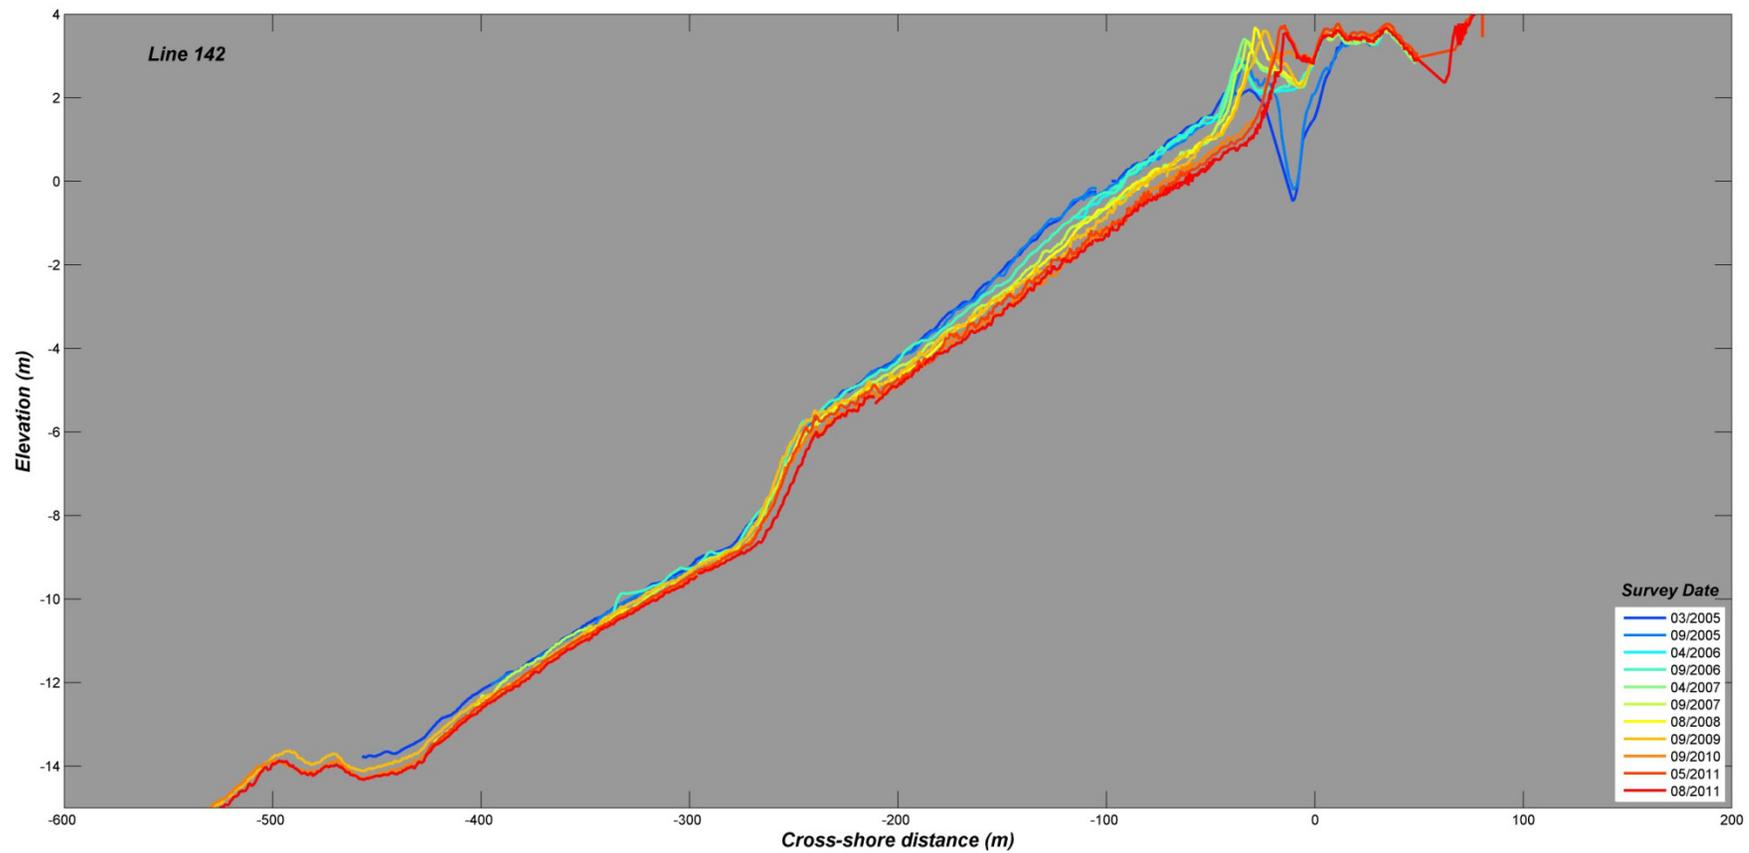
Figure 3. Morphological change observed along Line 142 between 2005 and 2011, located west of the river mouth (see fig. 2 for the Line location).

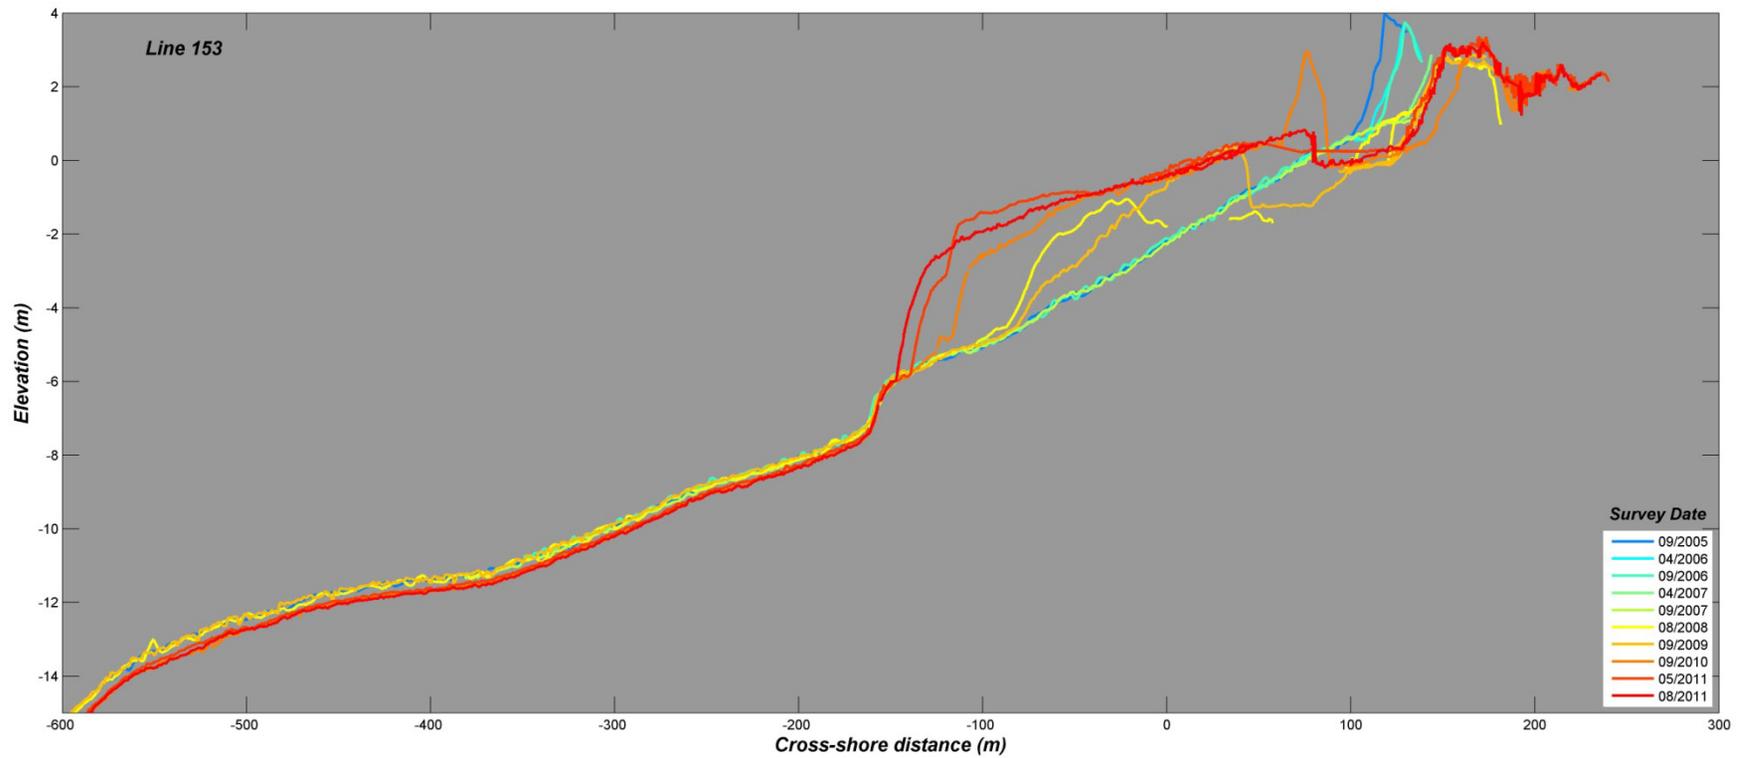
Figure 4. Morphological change observed along Line 153 between 2005 and 2011, located in the river mouth (see fig. 2 for the Line location).

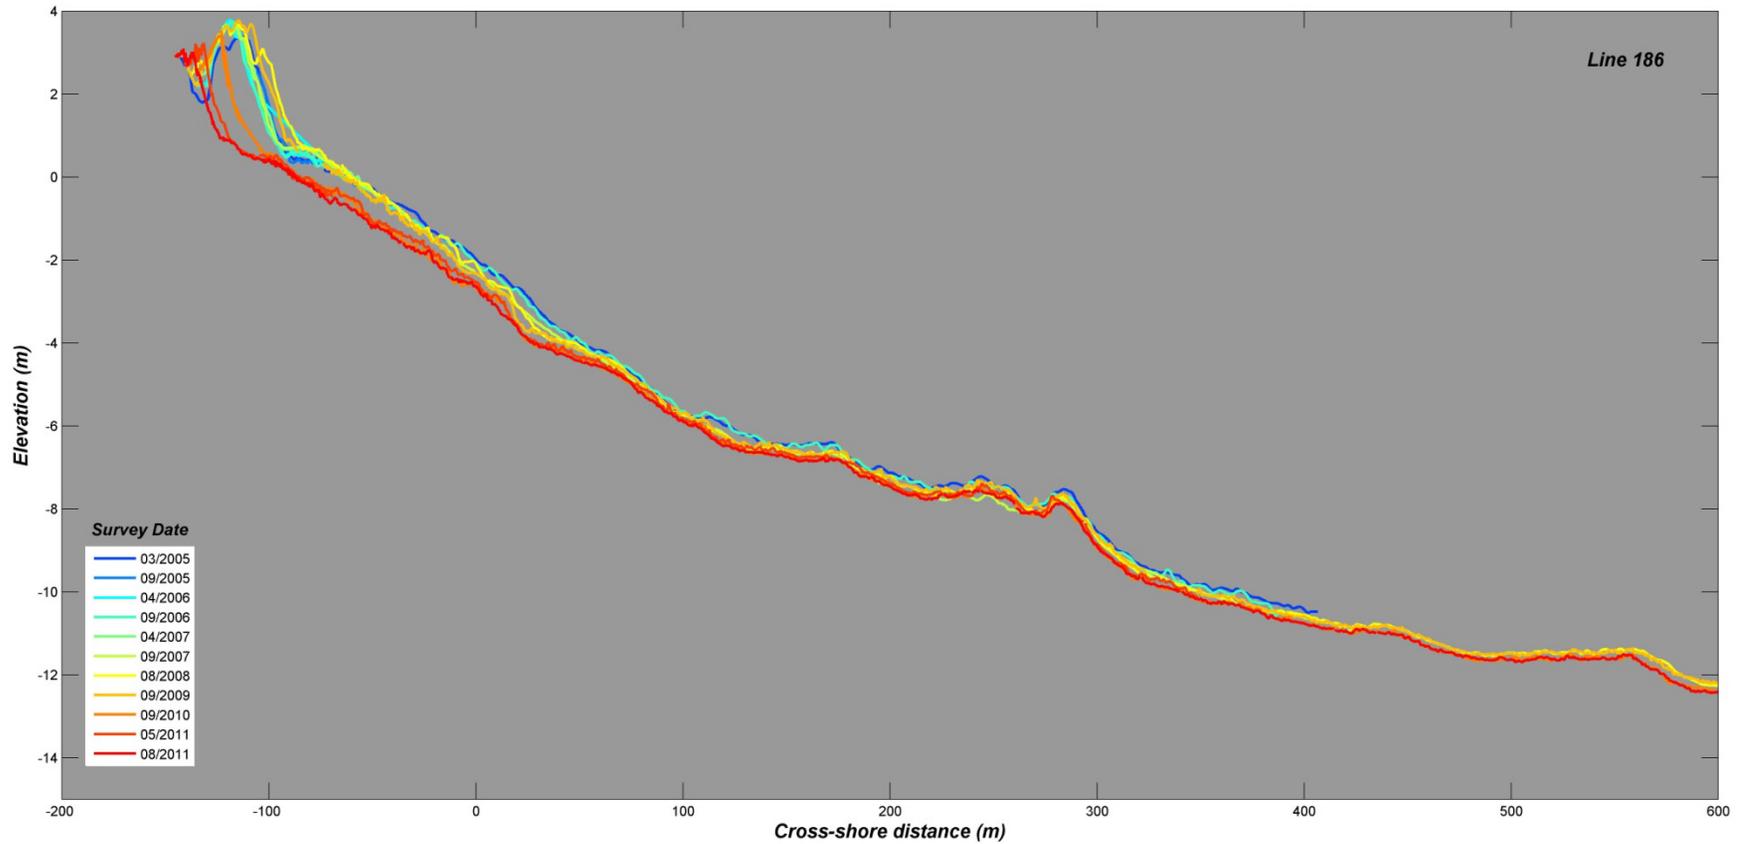
Figure 5. Morphological change observed along Line 186 between 2005 and 2011, located in central portion of the river delta(see fig. 2 for the Line location).

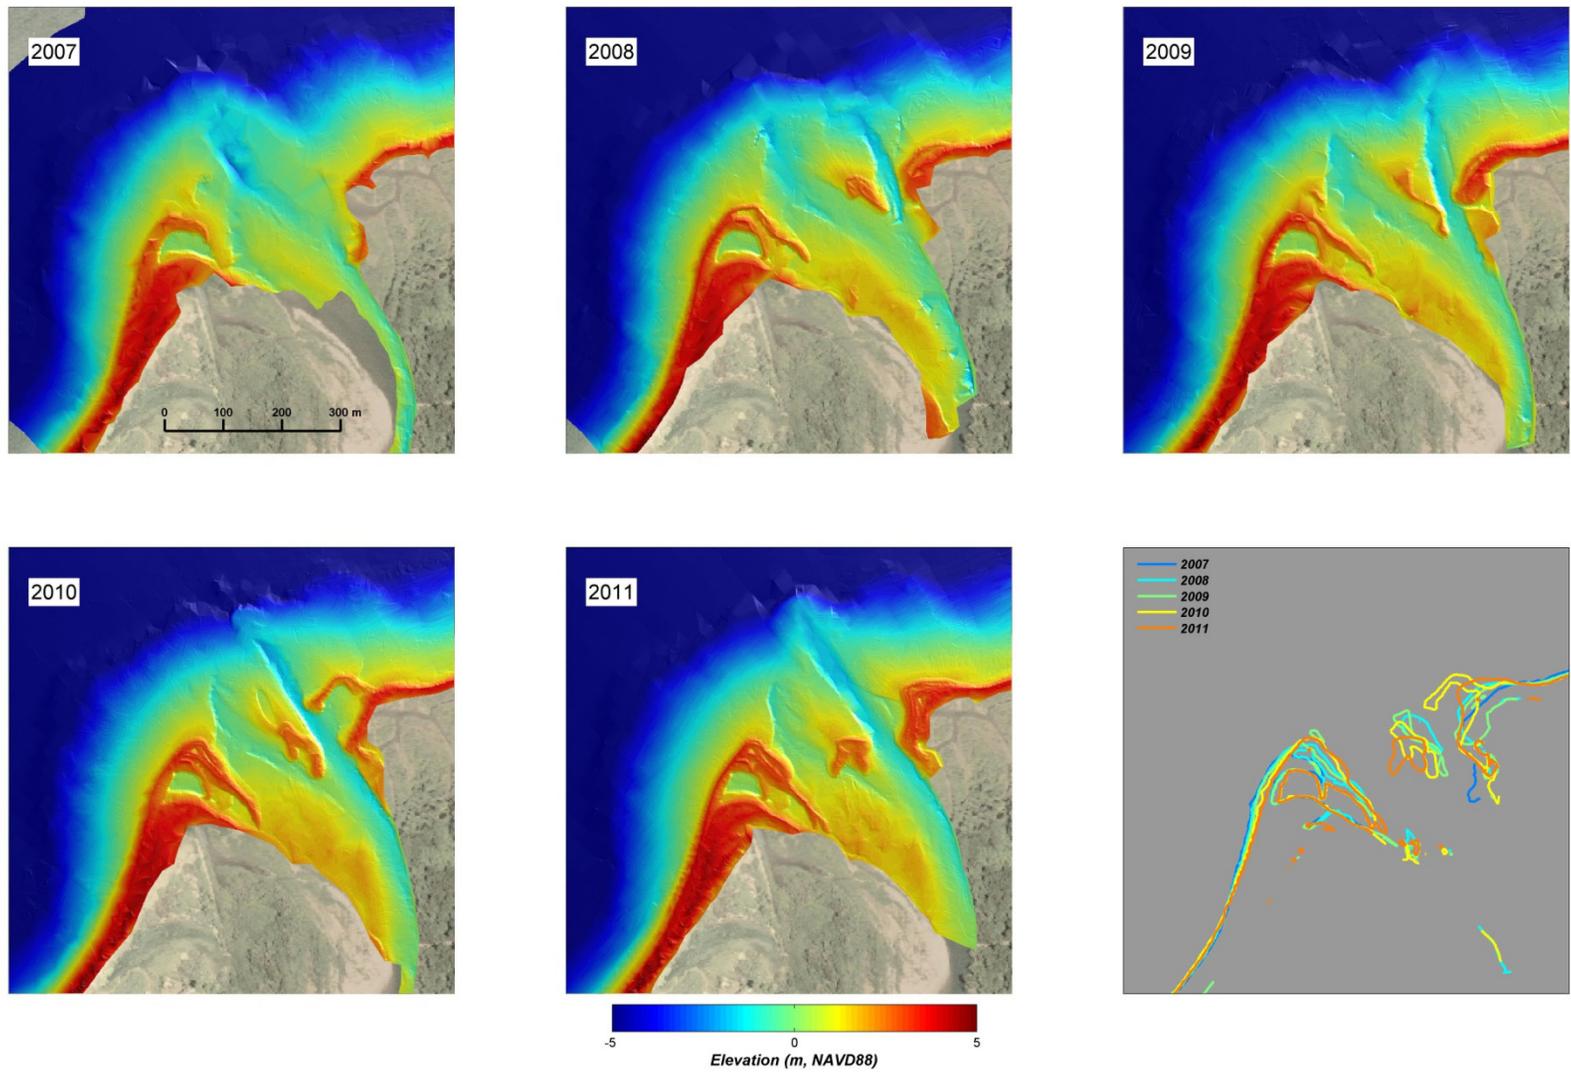
Figure 6. Interpolated elevation models of the river mouth region (1-m grid resolution) showing the change in the configuration of the river between 2007 and 2011. Bottom right panel shows changes in the 2-m contour over time.
