9.0 EFFECTS OF GROUND FAILURE ON BRIDGES, ROADS, RAILROADS, AND LIFELINE SYSTEMS

9.1 Introduction

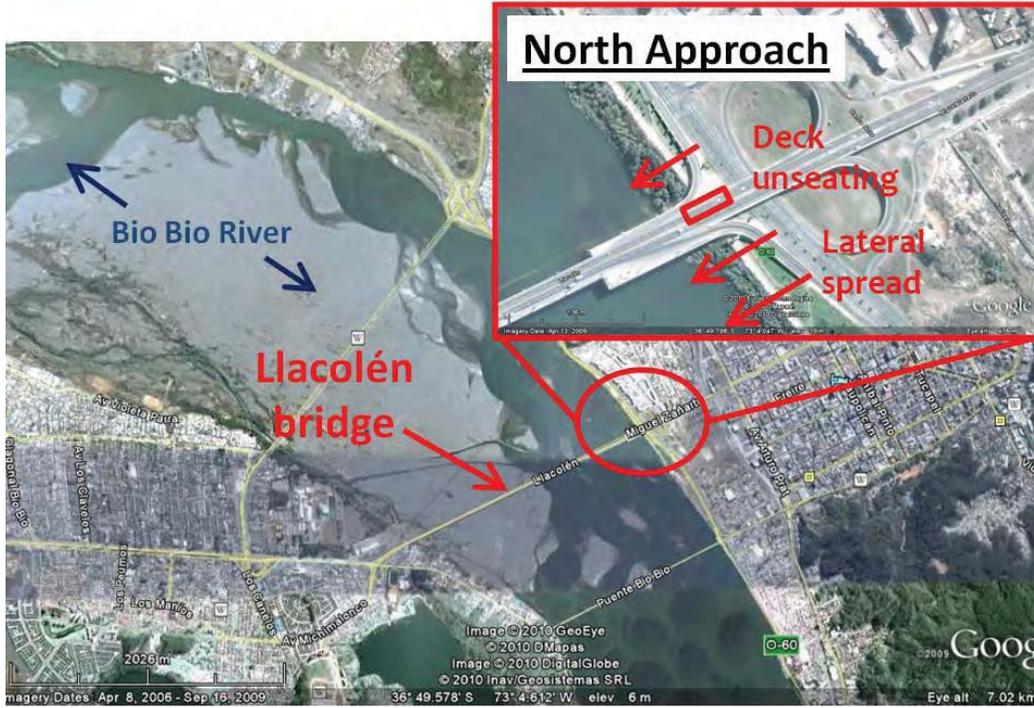
Lateral spreading ground was observed at the Llacolén Bridge in Concepción on the North approach shore (Figure 9.2). The Llacolén Bridge in Concepción was constructed in 2000 and spans 2,160 m across the Bio Bio river supporting four lanes of vehicular as well as pedestrian access to downtown Concepción (Figure 9.3). Ground damage at the north approach area was observed to extend inland into the southbound traffic lane of Calle Nueva road and south below the bridge's exit ramp continuing along a pedestrian walkway (Figure 9.4). Calle Nueva parallels the coastline and runs under the approach to the bridge. The lateral spreading ground resulted in unseating of the west and east bound traffic support deck (Figure 9.5). Flexural cracks on the river-side face of the 1.5 m diameter support columns were observed near the ground surface typically tightly spaced at approximately 0.10-0.20 m on center (Figure 9.6). The distribution of flexural cracking was more severe for those columns supporting the unseated deck, however, all columns at the north shoreline support observed flexural cracking at their construction joint (between 2-2.5m above ground surface). Ground settlement of 0.25-0.30 m was also noted to surround each of the exit ramp bents (Figure 9.7).

Figure 9.2. Plan view of the Bio Bio river region locating the damaged region of the Llacolén bridge in Concepción (S36.830108°, W73.067991°)

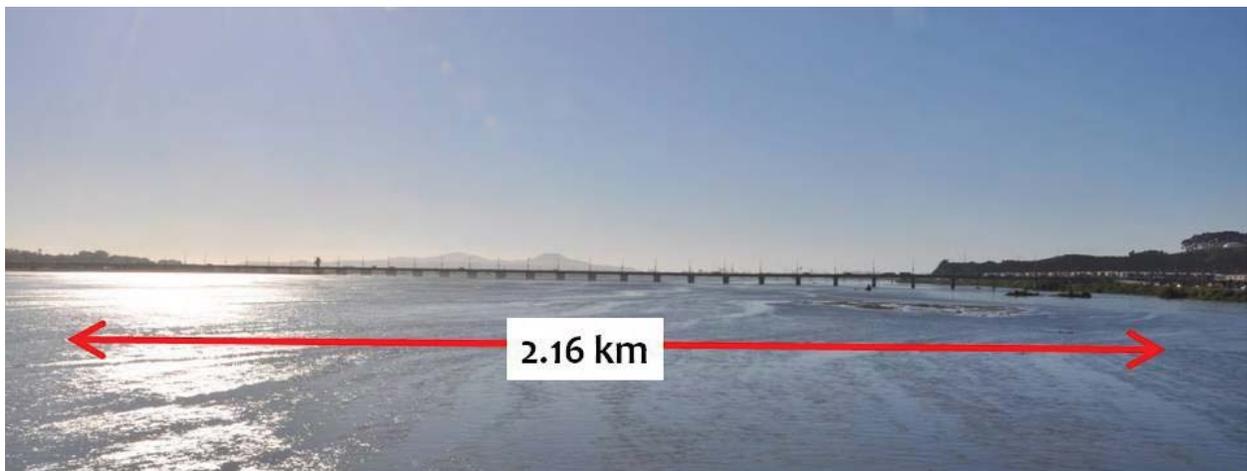
Figure 9.3 Elevation photograph of the Llacolén bridge in Concepción (S36.830108°, W73.067991°).

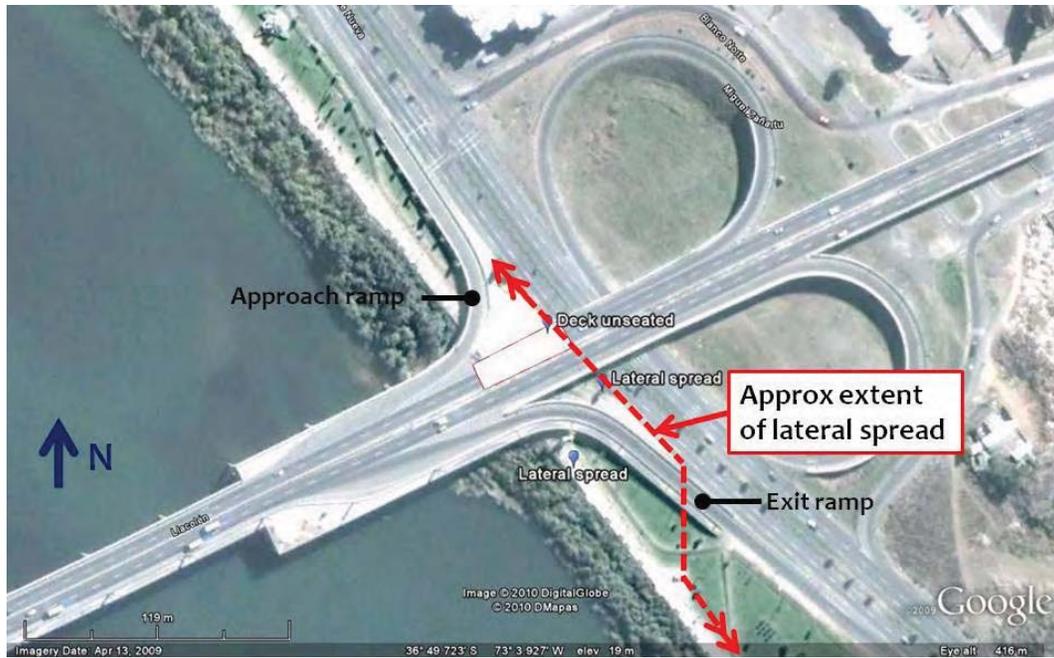
Figure 9.4. Plan view of the North approach to the damaged Llacolén bridge in Concepción ($S36.830108^\circ$, $W73.067991^\circ$).

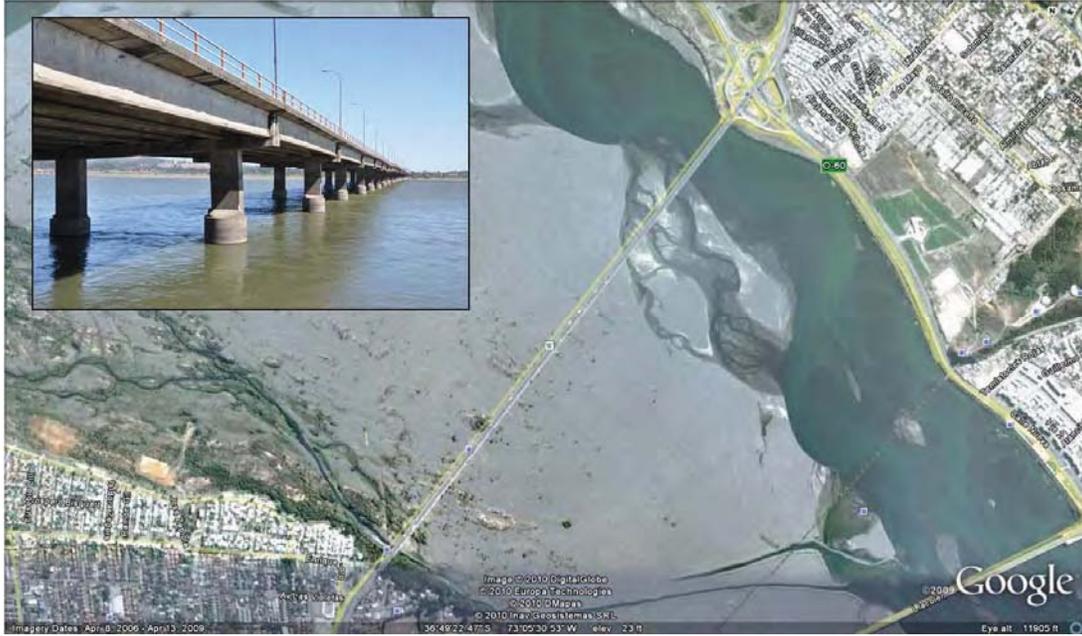
Figure 9.8. Juan Pablo II bridge connecting the cities of Concepción and San Pedro de la Paz across the Bio Bio River (S36.815122° W73.084369°; 1453 hrs on 3/15/2010)

During the 2010 Chile earthquake, the bridge suffered severe damage and was closed to the public. Evidence of liquefaction and lateral spreading was observed in the north-east approach with significant effects on the bridge. A Google Earth view of the northeast approach with schematics of the observed ground failure and structural effects is shown in Figure 9.9b. As shown in Figure 9.10, liquefaction of the soil and lateral spreading in the embankment contributed to settlements and lateral displacement of the bridge deck. Visual inspection of the surrounding soils indicated the presence of fine loose sands. Several sand ejecta features were observed near the structure on the south and north sides of the embankment as shown in Figure 9.12. Several samples of the ejected soil were taken at this site, and grain size analysis and Atterberg limit testing are being performed. The results of this testing will be included in later versions of this report.

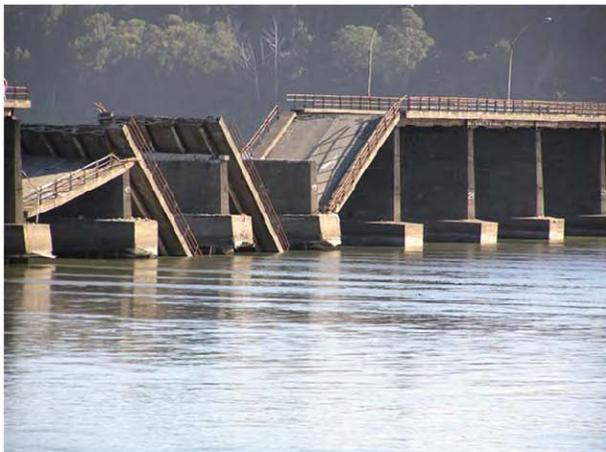
The Bio-Bio bridge, also known as Puente Viejo (Old Bridge), was built in the 1930s and inaugurated in 1937. The bridge connected the cities of Concepción and San Pedro de la Paz and had a length of 1,419 m. For many years it was the only vehicular bridge connecting the two cities. Due to its precarious structural condition the bridge was closed in May 2002 and used only for pedestrian transit. During the 2010 Chile earthquake the bridge suffered severe damage with many slab sections collapsing (Figure 9.24a). Several bridge bents also collapsed during the seismic event (Figure 9.25). Evidence of liquefaction was observed at the East bridge abutment with visible lateral deformations and vertical settlements.

Figure 9.24. Puente Bio-Bio: (a) Collapsed slabs (S36.836789° W73.062203° on 3/15/2010), (b) Evidence of lateral spreading near East bridge approach (S36.837311° -73.061831°; 1753 hrs on 3/15/2010).

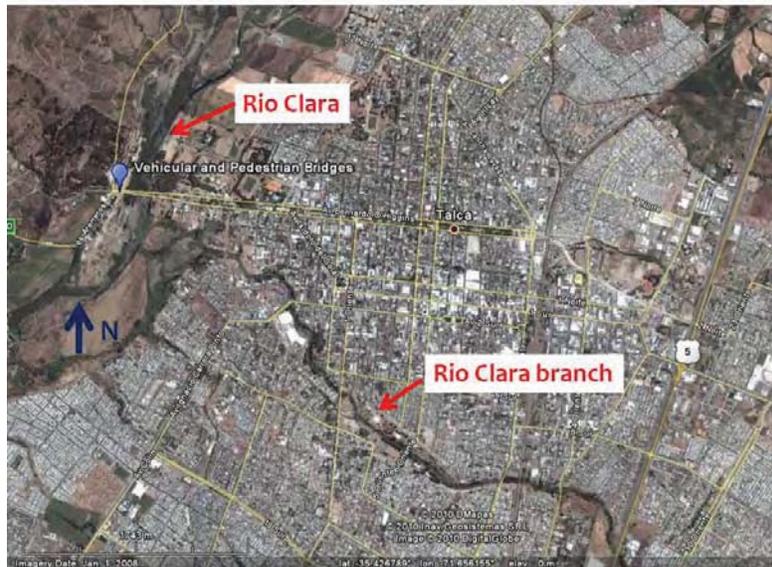
Figure 9.27. Plan view of city of Talca locating the Rio Clara and Rio Clara branch inspected by GEER team (S35.440800° W71.647233°).

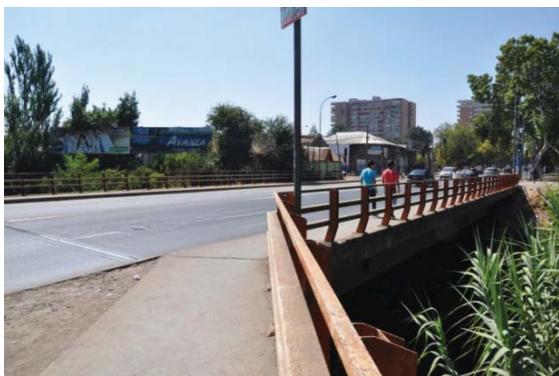
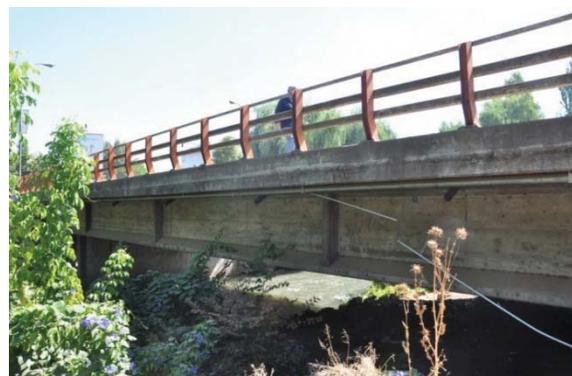
Bridges crossing the east-west branch of the river were primarily short span (less than 50 m long) slab bridges (Figure 9.28). Of the bridges inspected along the branch of the Rio Clara, no visible damage to the structure or surrounding ground was observed. Two long span bridges that cross the Rio Clara), one a vehicular bridge, the other a pedestrian bridge (Puente Rio Claro Nuevo and Puente Rio Claro Viejo) (Figure 9.29) were also of interest. Both structures are constructed of reinforced concrete, and of a girder-slab type configuration with the vehicular bridge bents supported on pier walls and the pedestrian bridge bents supported on angled multi-column subassemblies integral with a pier cap at both base and column head.

Figure 9.28. (a) Typical short span bridge construction on the branch of the Rio Clara, city of Talca (S35.428011° W71.670269°; 1302 hrs on 3/18/2010). (b) Bridges were observed to remain undamaged (S35.428086° W71.669894°; 1303 hrs on 3/18/2010).

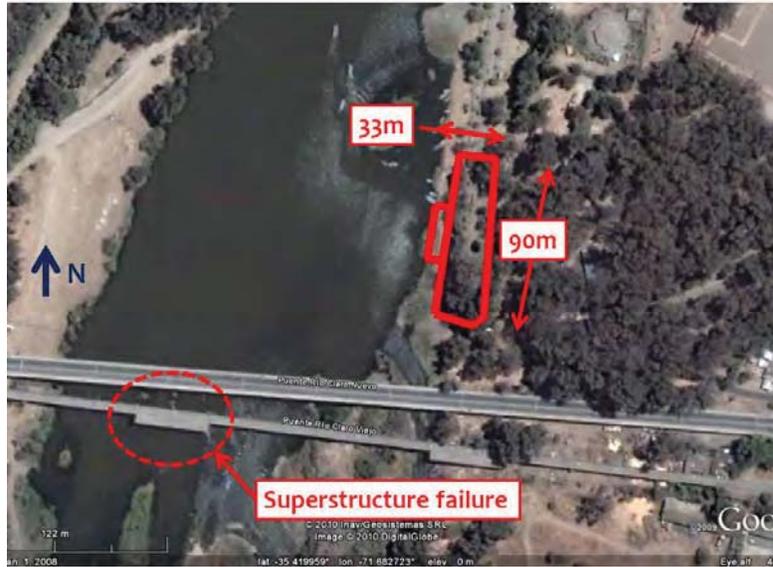
Local ground failure was observed approximately 50 m north of the Puente Rio Claro Nuevo (vehicular bridge) (Figure 9.30 and Figure 9.31). Two distinct regions were observed, a smaller lateral spread near shore (Figure 9.31), and a larger ground failure more characteristic of a soft clay failure confined within a park area (Figure 9.30). Soils near the shore area were predominantly gravely materials, likely with pockets of sand (one sand boil was observed at the near shore failure), whereas the park area was a soft clayey material. The ground failure extended approximately 90 m by 33 m north-south, however, it had no impact on the vehicular bridge, as it was open to traffic with no visible distress noted from the team's inspection on the east shore area. In contrast, the Puente Rio Claro Viejo (pedestrian bridge) suffered unseating of the longitudinally spanning girders and subsequent shear failure of the southern-most girder at a vista point near the mid-span of the bridge (Figure 9.32). From the team's limited access to the bridge it was not clear if the deck unseating was due to movement of the bent due to ground failure or excessive structural deformation at the bent.

Figure 9.29. Plan view of the Puente Rio Claro Nuevo and Puente Rio Claro Viejo, locating the observed ground failure area to the north ($S35.420772^{\circ}$ $W71.682932^{\circ}$).

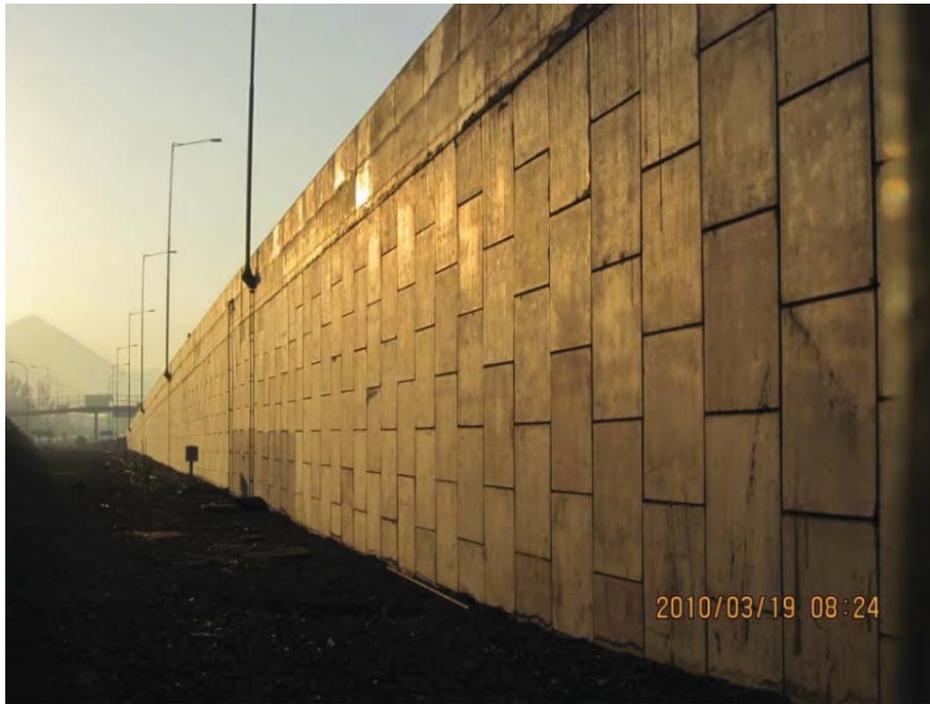
Retaining walls, MSE walls, and tie-back walls associated with transportation structures, including bridge abutments, appeared to perform well throughout the affected region. Even in locations of significant lateral spreading, which caused considerable damage, bridge abutments performed well.

Figure 9.35. Retaining walls and mechanically-stabilized-embankment (MSE) walls appeared to perform well in the Quilicura area of Santiago (S33.366137, W70.688913; 824 hrs on 3/19/2010)

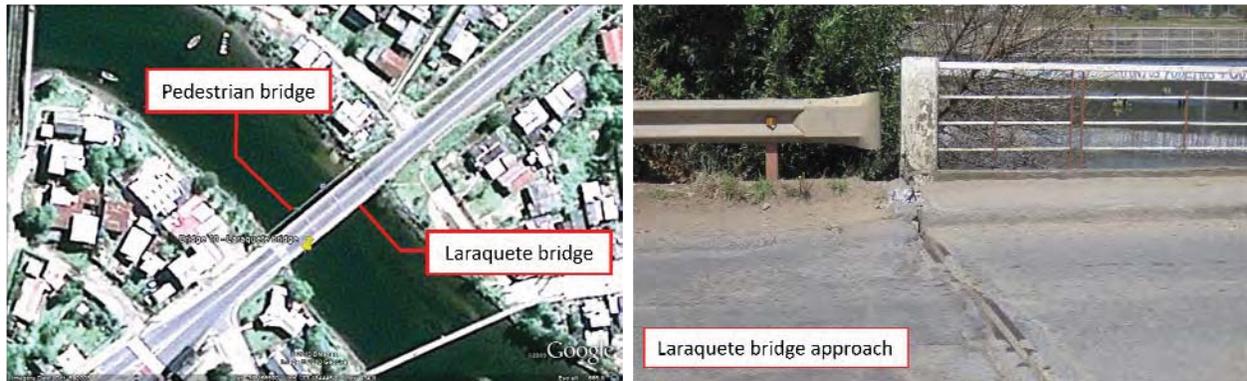
Two bridges were inspected in the Town of Laraquete, which is 50 km south of Concepción: A pedestrian two span bridge and an adjacent vehicular three span reinforced concrete bridge. The pedestrian bridge experienced damage due to foundation settlement of the middle bent with an estimated 0.50 m vertical deformation. Figure 9.41 shows the deformed bridge with noticeable inclination of the bridge deck. The adjacent reinforced concrete bridge, shown in Figure 9.40, suffered minor damage near the approaches due to pounding with the concrete structure and settlement due to poorly compacted fill. This bridge did not show evidence of foundation settlement.

Figure 9.40. Laraquete bridge (a) Aerial view (S37.166788° W73.184486°), (b) Bridge approach (S37.166804° W73.184760°; 1430 hrs on 3/10/2010)

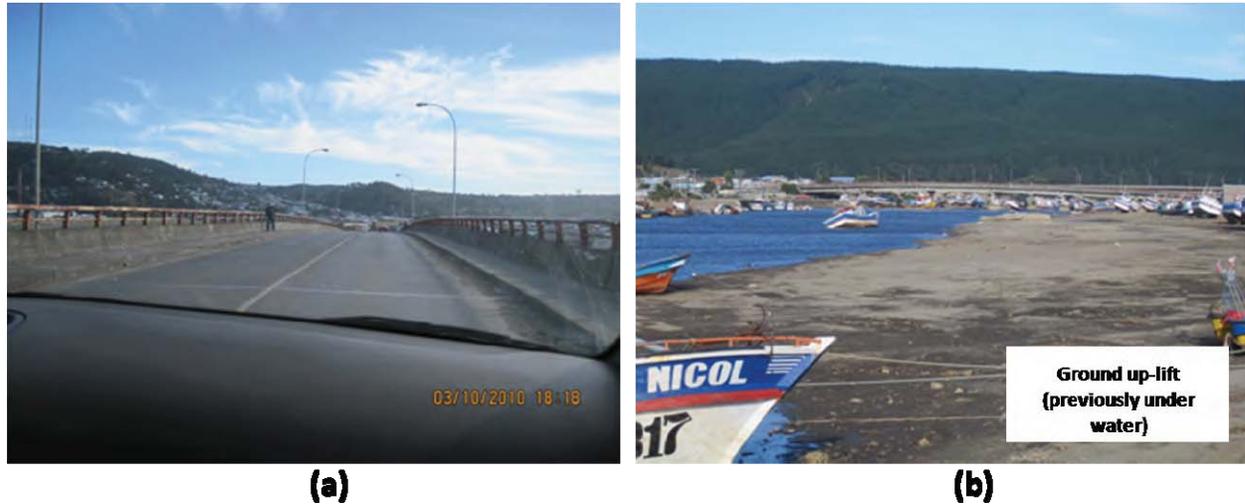
This bridge was operational by the time the GEER team got to Lebu. No major approach fill settlement could be observed. Good overall performance of the bridge in an area where evidence of ground uplift of 1.8 m to 2 m was found.

Figure 9.42. Lebu bridge: (a) Crossing Lebu bridge fully functional, and (b) Lebu bridge from the distance (S37.606344, W73.649496, 1818 hrs on 3/10/2010)

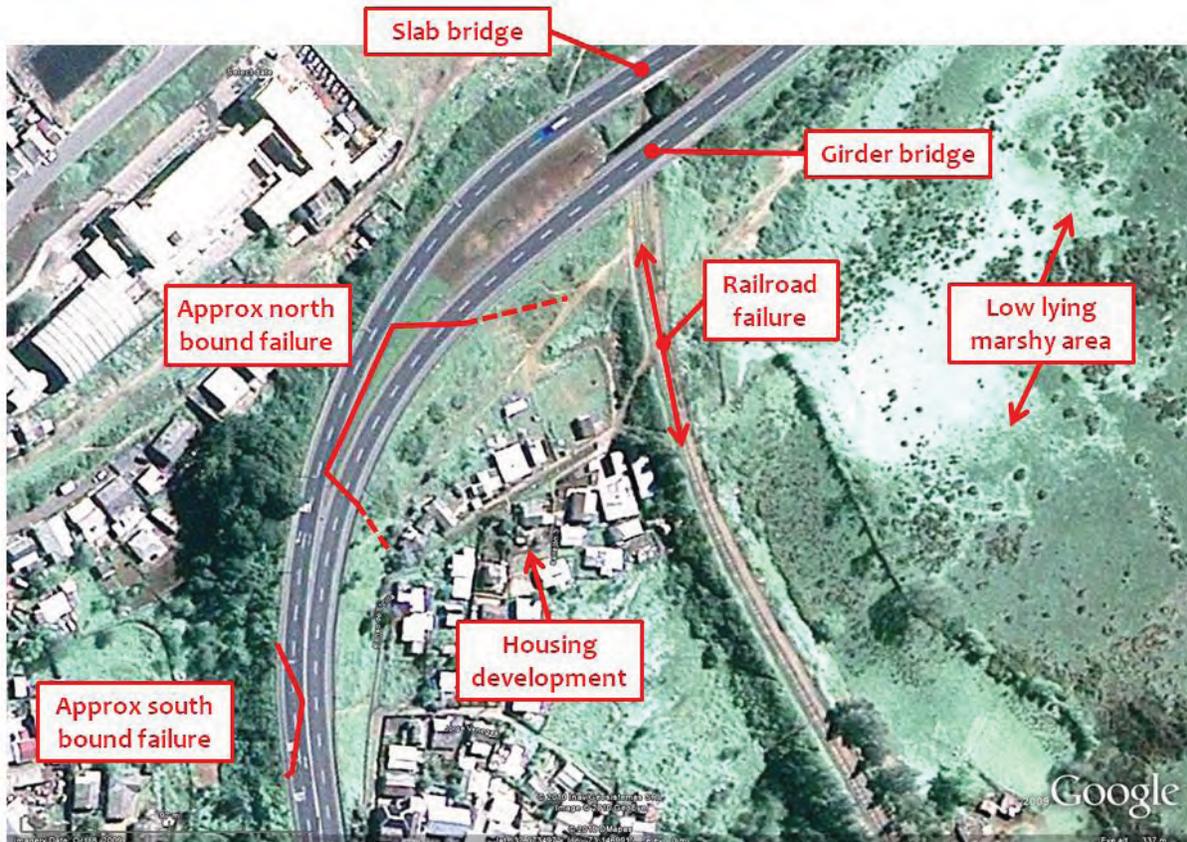
Several large ground failure areas were observed north of Lota along Route 160. Two failures resulted in damage to a roadway embankment section (denoted herein as the “south bound failure” and “north bound failure”; Figure 9.49), while a third failure resulted in damage to an elevated railroad section (denoted as “railroad failure”; Figure 9.47 and Figure 9.50). Minor side road spreading-like failures were also noted near the approach abutments to two short span overpass bridges, north of the embankment failures, as well as just north of the short span bridges. The area east of Route 160 is largely marshy with low lying organic material (Figure 9.47). South of the north bound failure and east of the south bound failure of the elevated roadway sections is a small housing development.

Figure 9.47. Plan view of approximate affected area (Google Earth image at S37.0734°, W73.1469°).
